Case Study

application | Landslide Repair
location | Jordan, MN
product | Miragrid® 5XT Geogrid

job owner | Dr. Lyle and Esther Kraugh
engineer | Gale-Tec Engineering, Inc.
installer | Rachel Contracting

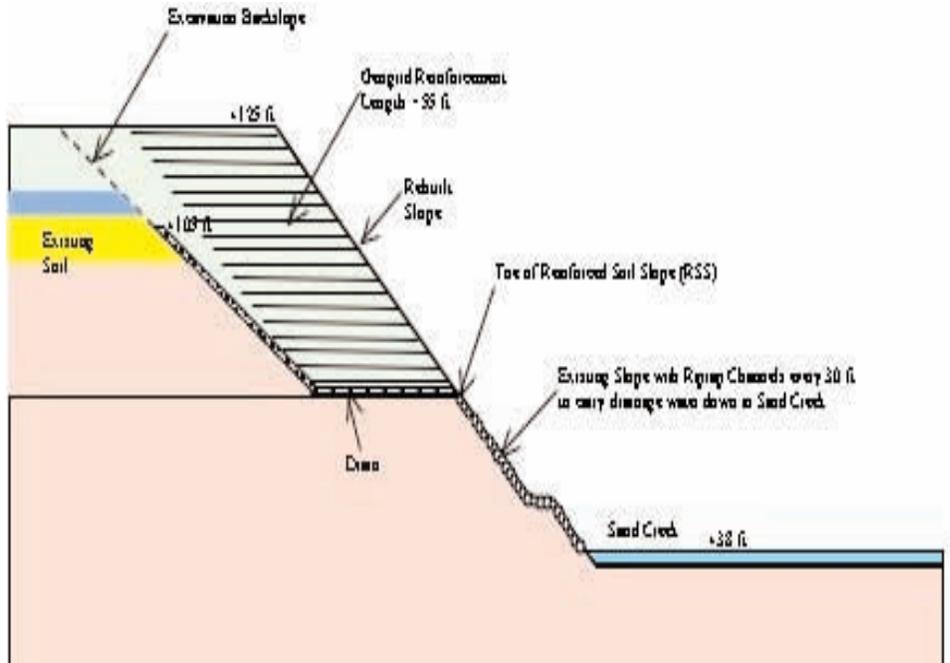
Figure 1.

Gale-Tec Engineering selected a reinforced soil slope (RSS) to repair the failed riverbank. The RSS consisted of Miragrid® 5XT and Miragrid® 8XT geogrid reinforcement layers placed in conjunction with a compacted granular backfill. The geogrid provides high tensile strength and high interface friction when embedded in soil. The stability afforded by the interaction between the geogrids and granular backfill allowed for re-construction of the slope at a 1H:1V angle. Figure 1 shows the Gale-Tec plan constructed by Rachel Contracting, Inc.
