Case Study

application Pavement Overlay
location Lanham, MD
product Mirafi® MPV500

THE CHALLENGE

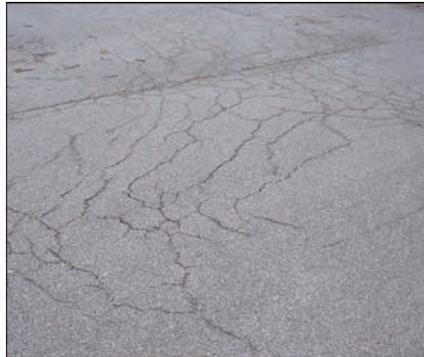
The existing asphalt pavement in The National Asphalt Pavement Association (NAPA) parking lot was experiencing considerable alligator cracking and was scheduled to be re-paved. After some site investigation, it was determined that more serious patching would be required due to the unexpected pumping that was observed in some areas of the pavement surface.

Alligator cracking observed in several areas.

After excavating a couple of test pits, everyone involved on the project realized that just a standard overlay would not be adequate. The majority view was that the appropriate repair would require full depth removal and replacement of the pavement cross section, over a wider area than originally planned. Due to the costs and time associated with this type of construction repair, everyone agreed that other options needed to be assessed. The decision, made by committee that included the contractors involved with input from the sitting President of NAPA, was to incorporate Mirafi® MPV500 to significantly reduce the surface water infiltration into the pavement, and to provide some stress relief between the existing surfaces/patches and the new overlay. While this was not thought to be the perfect fix, it was understood that this solution would significantly increase the longevity of the new overlay.

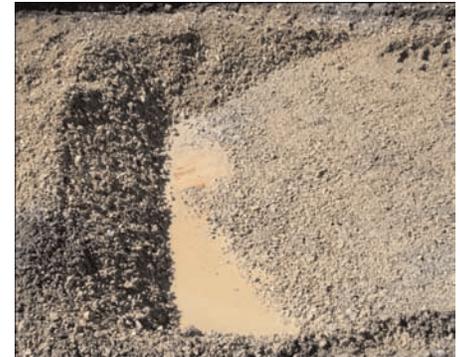
Wet, soft subgrade exposed in the test pit.

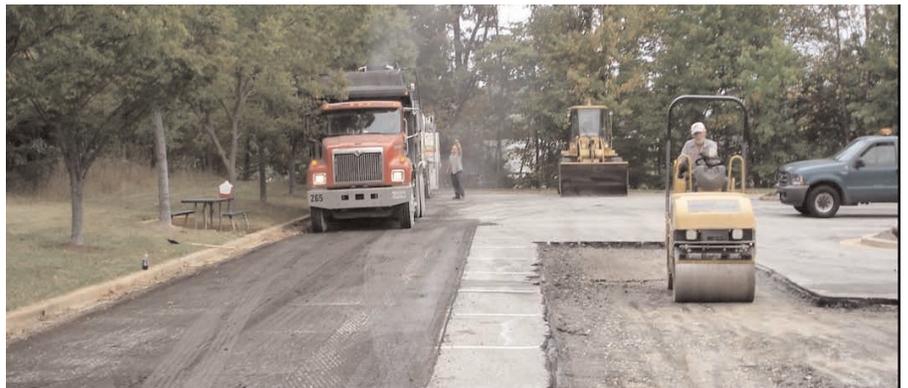
Recompaction of base course in test pit areas and edge milling being preformed.

After the edge milling and patching was completed, American Paving Fabrics, placed PG64/22 at a rate of approximately 0.25 gallons/SY over the prepared surface and placed the Mirafi® MPV500. The paving overlay machines followed right behind them with their HMA overlay.

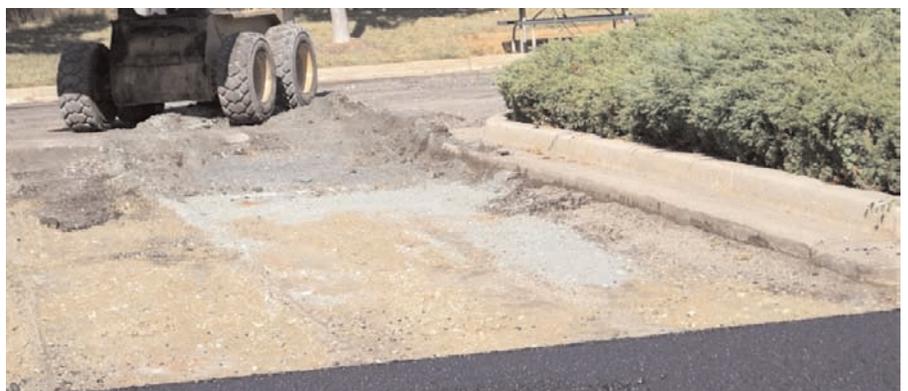
Base course being replaced.

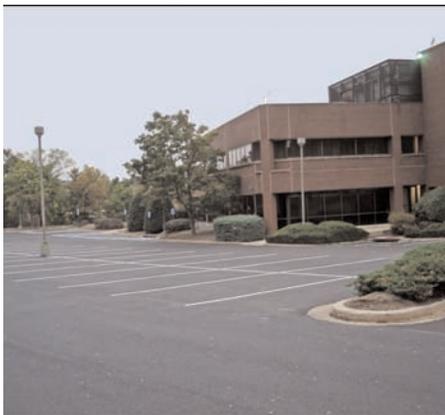
Finished parking lot.

The finished pavement looks great and will be inspected going forward to determine the increase in service life that the interlayer system provided. Each of the contractors involved in the pavement rehabilitation project were given a NAPA Recognition Award at their February 2008 conference.

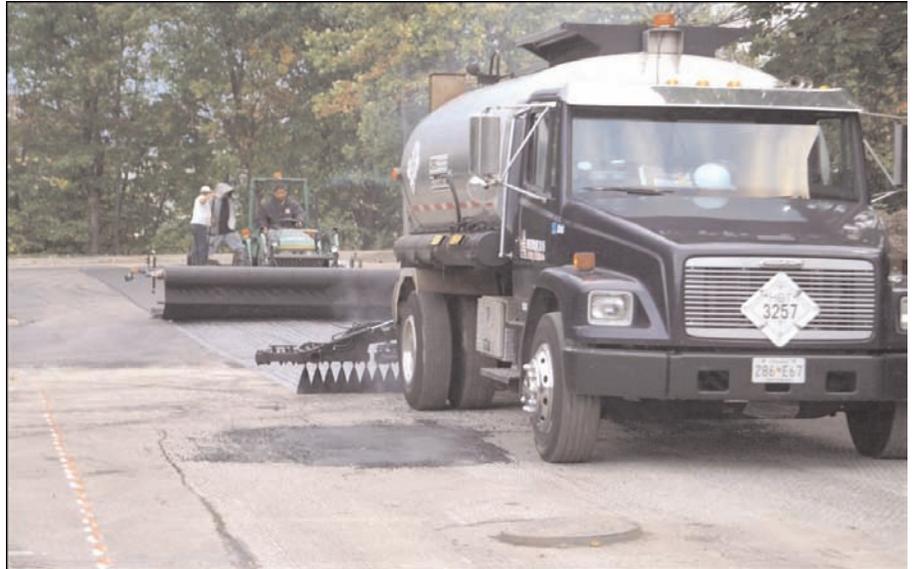
Distribution truck shooting PG64/22 asphalt cement with paving fabric being placed behind it.

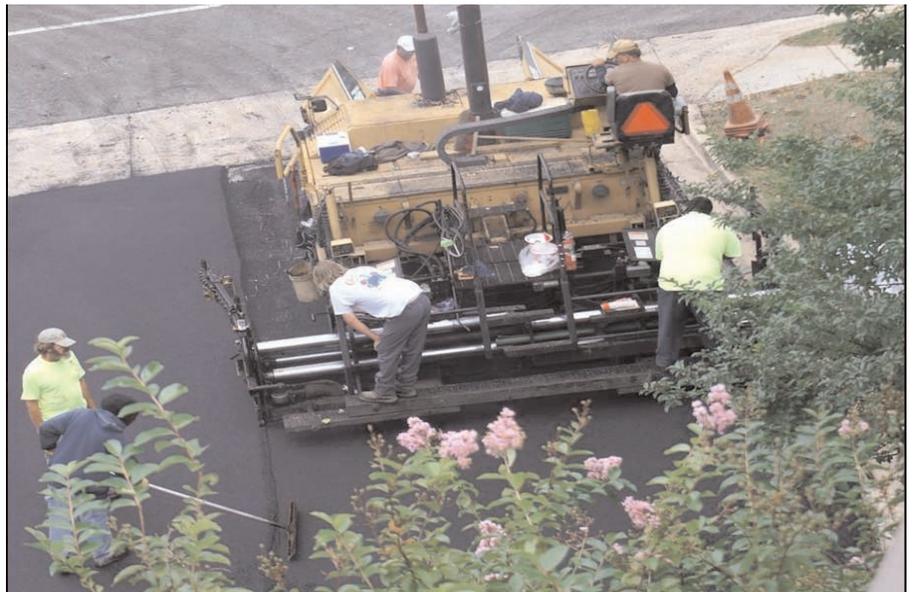
Asphalt surface mix being placed.
