Case Study

application	Lagoon Cleanup
location	Dundee, Oregon
product	Geotube® Dewatering Technology

job owner
**Duck Pond Cellars
Dundee, Oregon**

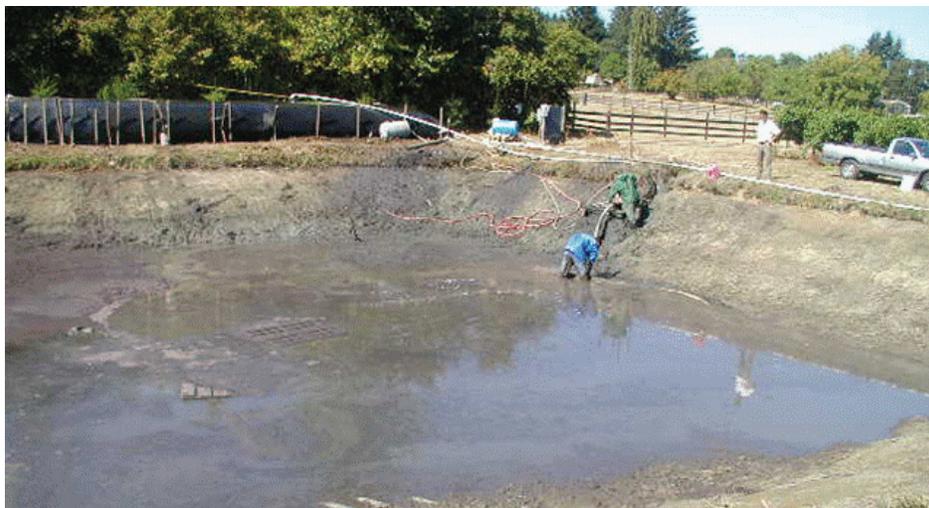
Figure 1. Cleaning the lagoon with Geotube® unit in the background.

system. The first order of business, however, was to clean out the winery’s lagoon before creating the Geotube® dewatering technology/SFF water treatment system (see Figure 1).

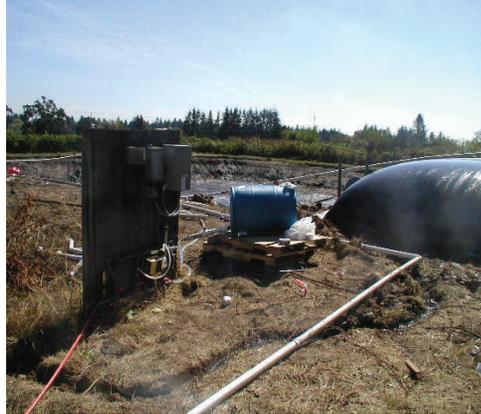
Figure 2. Polymer metering system with Geotube® unit.

Figure 2 shows the cationic polymer metering system which injects the conditioner into a simple serpentine mixing chamber before injection into the Geotube® unit.

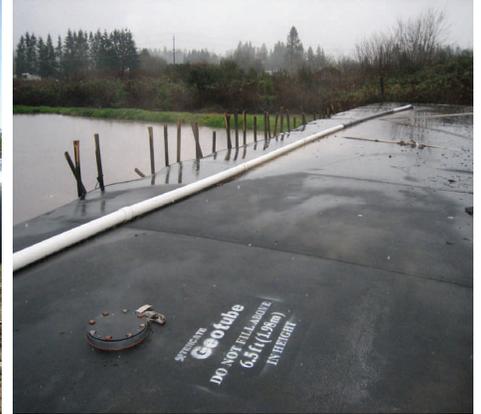
Figure 3. Filled Geotube® unit next to clean lagoon.

Figure 3 shows the completely filled Geotube® unit next to the lagoon. Figure 4 shows the cleaned lagoon with an aeration system now in place. The dewatered lagoon material will eventually be applied to the adjacent pinot noir grape vineyards.

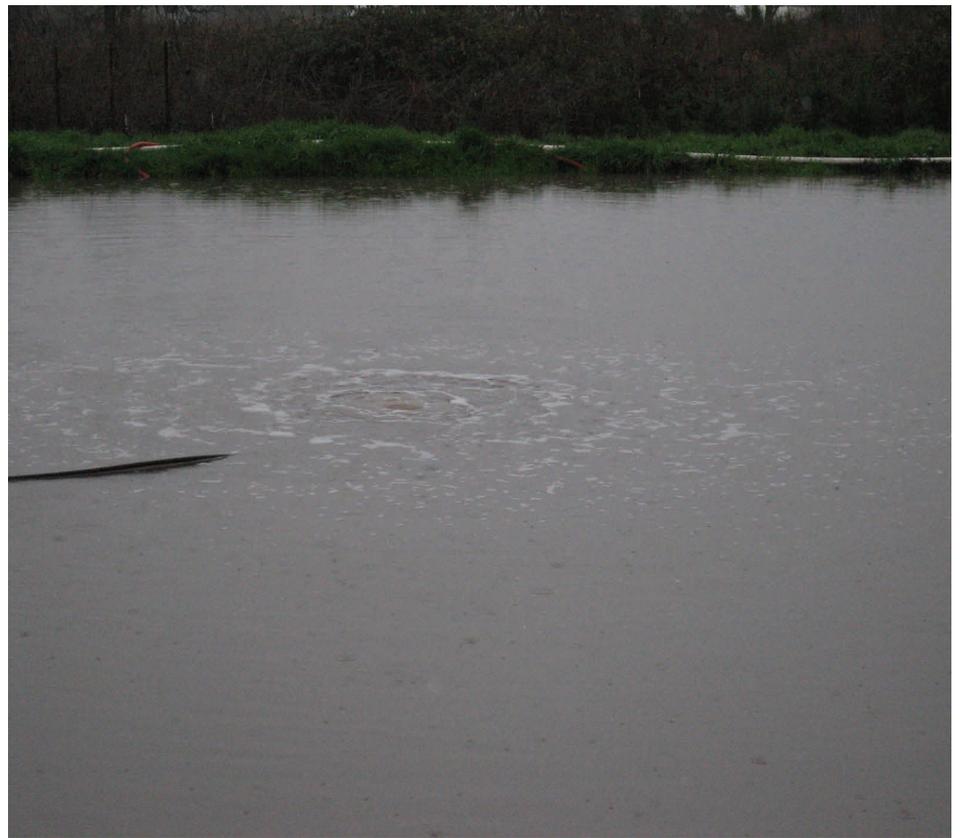
Figure 4. Aeration system providing aerobic digestion to the clean lagoon.
