## Case Study

**application** | Test Section for Haul Roads  
**location** | South Central, TX  
**product** | Mirafi® HP270

**job owner** | Gulf Wind #1  
**engineer** | Design Build Project

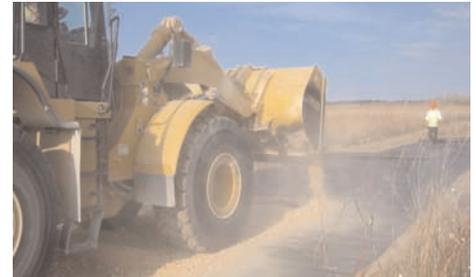
Placing caliche on textile road test section.

The haul road area at the site was stripped of vegetation and then the subgrade was wetted down and rolled 5 times with a smooth drum roller until minimum deformation of the subgrade occurred under loading. Two roll widths of Mirafi® HP270 geotextile were placed for each 20 ft wide road section. Because of high residual water table and the potential for flooding of the site during rain events, a raise in grade was required at some locations. Before installing the geotextile, a sheep's foot roller was used to compact the existing soil and light vegetation, then suitable fill placed where they needed to raise the grade above standing water elevation. After the subgrade was leveled, Mirafi® HP270 geotextile was installed and the caliche was placed, graded and compacted. The required thickness of the caliche depended on the elevation of the water table adjacent to the roadways and whether the soil contained more sand than silt. An approximate 8" aggregate thickness sufficed for most of the project cross sections.

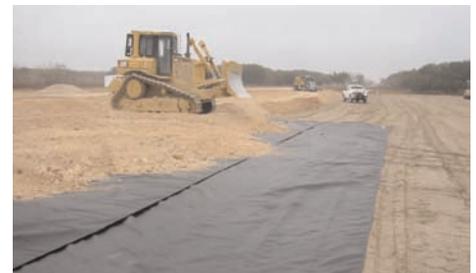
Placing caliche on textile over parking lot.

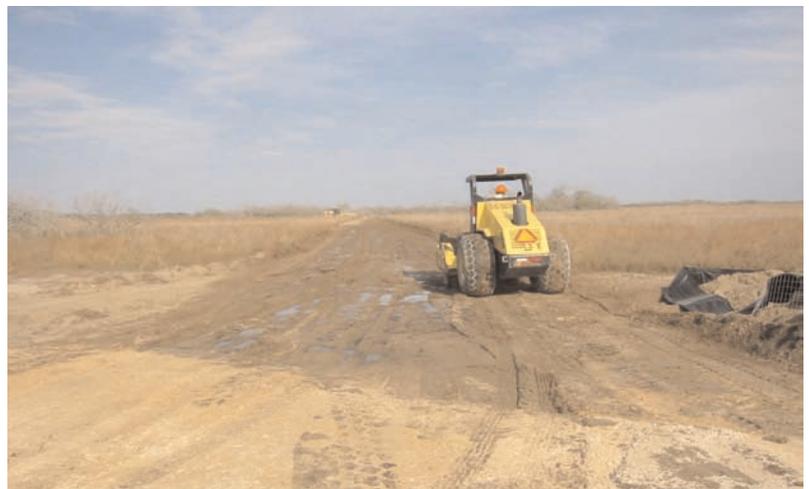
Wet subbase before placing geotextile.

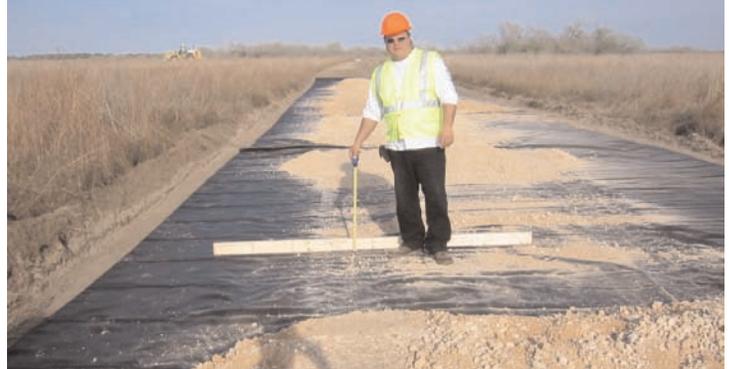
Mirafi® HP270 geotextile shows capsulation of base material in rutting zone.

Proof-rolling tests were performed on the caliche and subgrade both with, and without geotextile stabilization. Upon rolling over the caliche, where a Without geotextile stabilization, deformations of 2-3 inches occurred as shown in the adjoining photos. This deformation would have resulted in the loss of the imported caliche fill, both during initial road construction and long-term. Because of the high water table anticipated at many of the roadway locations, the geotextile stabilization must have very good permittivity, high strength at low strains (high tensile modulus). To meet these requirements, Mirafi® HP270 stabilization geotextile was selected for the project. A biaxial geogrid was also considered for haul road stabilization for the project but was rejected since the geogrid has large openings which would allow the intermixing of soft, wet subgrade soils with the caliche, resulting the degradation of the pavement section.

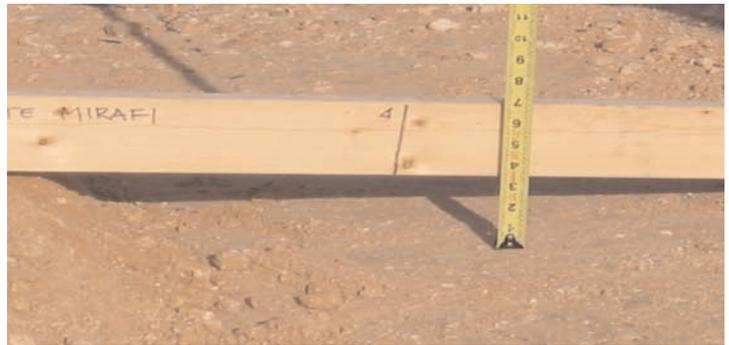
3" to 4" rutting after one pass of construction equipment.
