Monitoring of Earthdams Leaks and Stability with Fibre-Optics based Monitoring System

Abstract

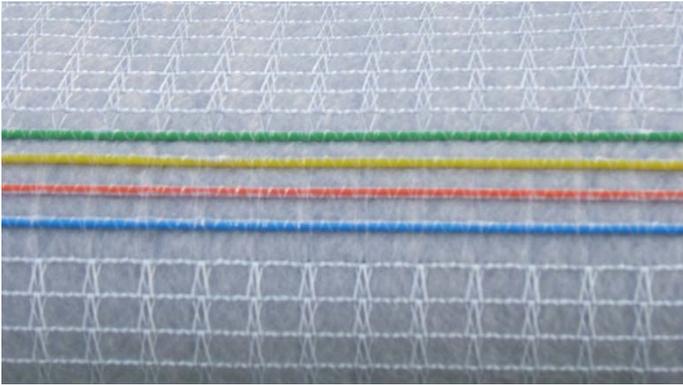
Figure 1: The TenCate GeoDetect® S-BR textile composite sensor embedding 2 optical cables for temperature and 2 for strain measurement

The fiber optics have been widely used for many years in civil engineering applications and specially hydraulic works such as concrete and earthdams, levees and dikes. By embedding optical cables into a geotextile fabric (Figure 1), GeoDetect[®] is the first system designed specifically for geotechnical and hydraulics applications. The geotextile fabric, e.g. a textile installed in the soil, enhances its mechanical and hydraulic properties by in-plane drainage capability, anchoring interface with the soil, soil reinforcement, separation and filtration. For example the drainage properties of the geotextile combined with the temperature measurement with the optical fibers improves the speed of leakage detection by collecting the water-flow and draining it faster to the optical fiber. Moreover, the filtration properties of the geotextile increase the stability of the soil to prevent the internal erosion process.

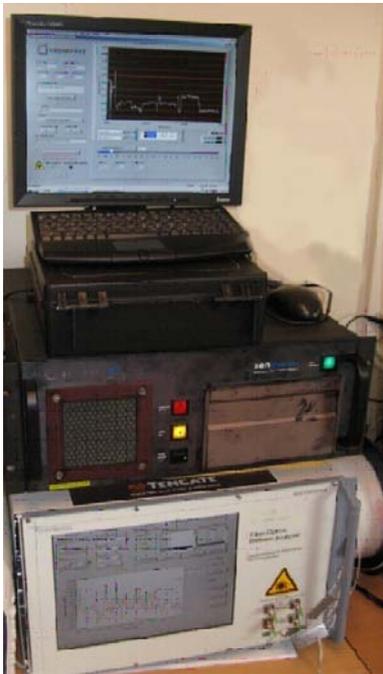
Figure 2: The Raman instrumentation for temperature measurement (on top) and the Brillouin instrumentation for strain measurement (at the bottom)

Combined with the appropriate software and instrumentation (Figure 2), it provides an innovative solution for the multi-functional requirements of geo-technical and hydraulic applications in addition to data capture. Different monitoring strategies may be designed, for example temporary monitoring, or continuous monitoring to be used as an early warning system.

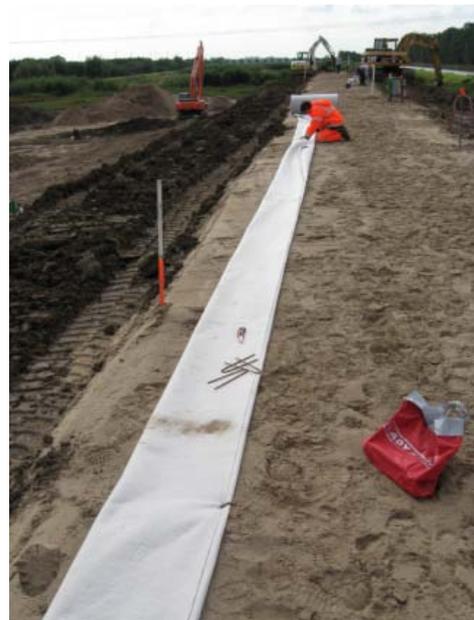
Figure 3: Installation of one GeoDetect® S-BR sensor strip in the IJkdijk macro-stability dike.

Beside the hardware components of the system, important parts of this global solution are the design and implementation of the system within the work (Figure 3) and the interpretation of the raw thermal and strain data. The detection of very small water pipes (or wormholes) for example has been improved recently. The physico-statistical and signal processing methods developed by EDF and used by geophyConsult allow the proposed system to be able to send « early warnings » which is compatible with long-term monitoring. The GeoDetect® solution has been validated on several 1:1 scale experimental works and real dikes in-use, as presented in the next sections.

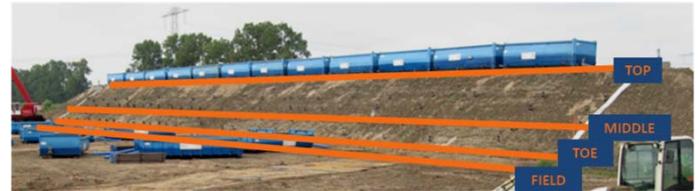
Figure 5: Placement of the 4 GeoDetect® sensor strips along the IJkdijk macro-stability dike, at the crest (TOP), at the middle of the slope (MIDDLE), at the dike downstream toe (TOE), and 2 m from the downstream dike toe (FIELD).

The fiber optics GeoDetect® system was installed lengthwise to the dike at four different levels: top on the crest, at the middle, at the toe of the down-stream slope, and 2 m meters away from the downstream toe (Figure 5). The four strips, 100 m long each, were all connected together in a loop to the instrumentation in a cabinet at about 50 m from the experimental dike. Both optical cables for strain measurement using the Stimulated Brillouin Scattering and for temperature compensation measurement using the Raman Scattering technologies were embedded onto the textile strips.

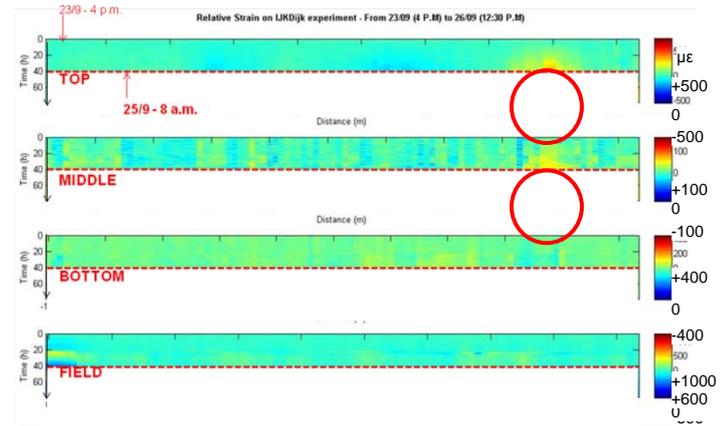
Figure 6: Relative strain measured on Sept. 25th 08:00 a.m. with the TenCate GeoDetect® system, 2.5 days before dike collapse : 0.03 % on the top strip, 0.005% on the middle strip (geophyConsult data processing).

In September 2008, during the test, the global factor of safety of the dyke was decreased step by step by digging a trench at the downstream toe and by increasing the internal water pressure till failure by slippage of an area of the downstream face. The failure took place on the third day of the test, during bright sunny conditions. The visible part of the failure took only 40 to 50 seconds, so it was a fast process. The monitoring system worked perfectly as it was able to detect and localize the early signs of soil movements 2.5 days before the dike collapses, i.e. only one day after the start of the experimentation. Very small soil strains of 0.03 % on the top strip and less than 0.01% on the middle strip were measured, see round red circles in Figure 6. The borders of the instable zone inside the dyke body were clearly localized more than one day before the failure occurred, when nothing was visible from out-side (Figure 7). They exactly correspond to the area of the slipping slope.

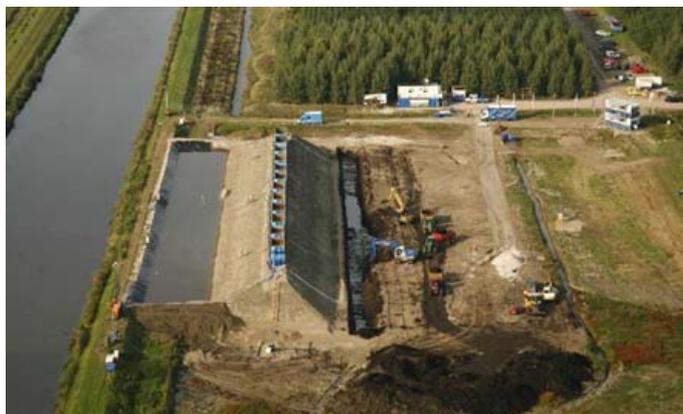
Figure 4: Aerial view of the IJkdijk experimental dike during the macro-stability experiment, the upstream basin on the left filled with water, loading containers on top, and the trench digged out 2 m from the dike toe.

First stages of dike settlement or sliding are detected by strain measurement. An experimental dyke 100 m long and 6 m high was built within the Dutch IJkdijk (Smart Calibration Dike) project to test the ability of sensing systems to detect dam failure due to internal instability (Figure 4). The IJkdijk-site is located in the North-East of the Netherlands, close to the German border.

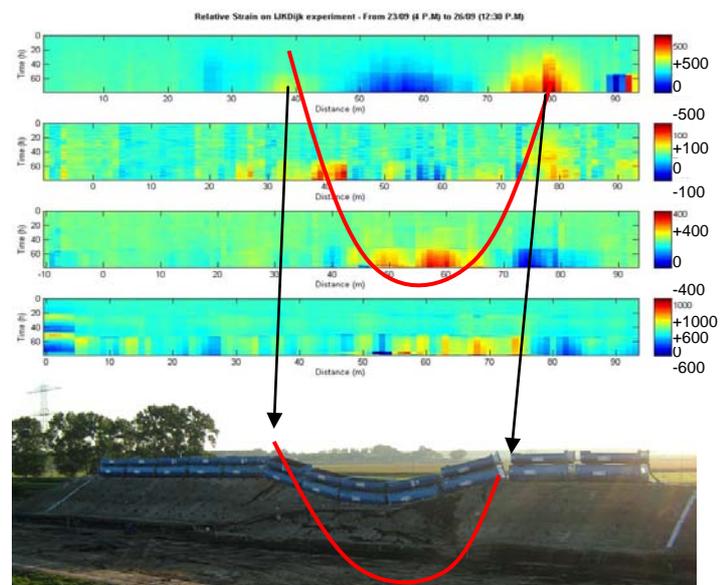
Figure 7: Relative strain measured on Sept. 26th 04:00 p.m. with the TenCate GeoDetect® system, 1 day before dike collapse : the tension zones on each strips draw the boarder of the slope slipping area (geophyConsult data processing).

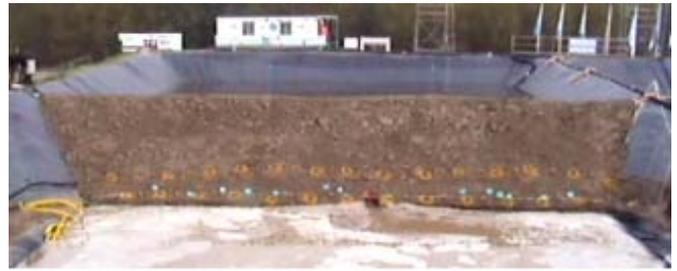
Figure 8: Downstream side of the IJkdijk experimental dyke a few minutes before collapse with clear view of the piping channel and sand erosion at the toe. The coloured labels at the toe indicate the observed flows, red with sand transport, blue only water (from Stichting IJkdijk).

continuously to detect water outlets, with or without soil transport. The test stops when the dike collapses (Figure 8).

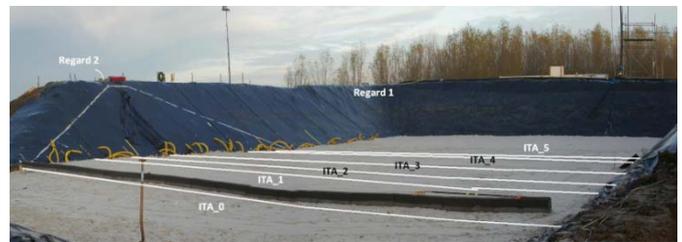
Figure 9: Location of the 6 GeoDetect® strips into the sand below the IJkdijk experimental dike.

As for the macro-stability project, several detection methods were tested. Among them, the GeoDetect® system was installed in the test number 4 : three textile sensor strips embedding fiber optics for both temperature and strain measurement were buried 10 cm into the sandy subsoil lengthwise the dike at three different locations ITA0, ITA1 and ITA2 from the downstream toe of the dike as indicated in figure 9. The temperature optical line was connected to Raman Scattering instrumentation, the strain optical line was connected to Stimulated Brillouin Scattering instrumentation. Even though the right detection place would be the interface

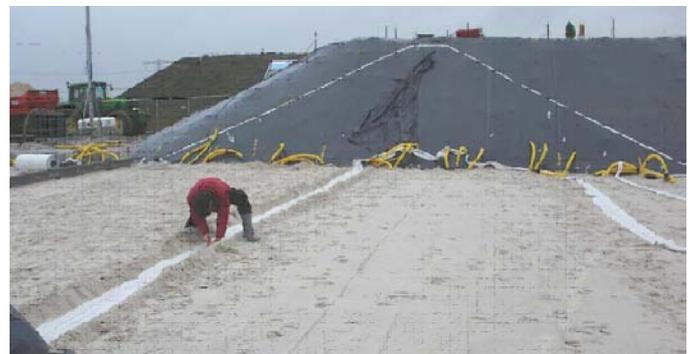
Figure 10. Installation of the GeoDetect® sensor strips embedding both strain and temperature fiber optics 10 cm into the sand layer before construction of the dike.

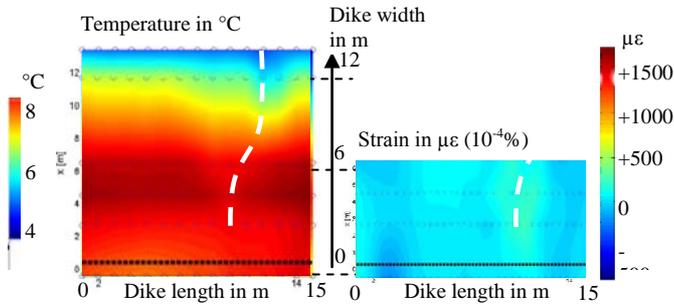
Figure 11: IJkdijk piping dike - Temperature (left) and strain (right) profiles measured on Dec. 4th 06:00 p.m. with the TenCate GeoDetect® system, 22 hours before dike collapse. Heterogeneities appear on the map (white dot line) (geophyConsult data processing).

Figure 11 shows the maps of the raw temperatures (left column) and of the relative strains (right column) measured by the GeoDetect® system. The temperature profile is disturbed due to the penetration of a colder water flow inside the dike body at distance of about 12 m from the left upstream corner and an inflection of the channel inside the dike body predicting a channel outlet in an area between 8 to 10 m from the left downstream corner. The strain profile on the left is also slightly modified at the same distances with an elongation of the sensors corresponding to about 500 $\mu\epsilon$ or 0.05 % (dotted white lines). From the observation of these two parameters, this clearly indicates that the start of the piping channel from the upstream side to the down-stream side of the dike took place before December 4th, 2009 at 6

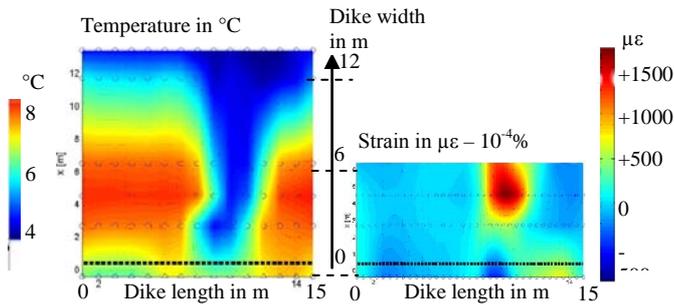
Figure 12: IJkdijk piping dike -Temperature (left) and strain (right) profiles measured on Dec. 5th 11:00 a.m., 5 hours before dike collapse from the raw data on the Ijkdijk piping test n°4 showing the extension of the piping channel bellow the dike (geophyConsult data processing).

p.m., i.e. more than 15 hours before the dike failure occurs. This is confirmed by the evolution of these parameters till December 5th, 2009 at 11 a.m (Figure 12), 5 hours before the dikes collapses (Figure 13).

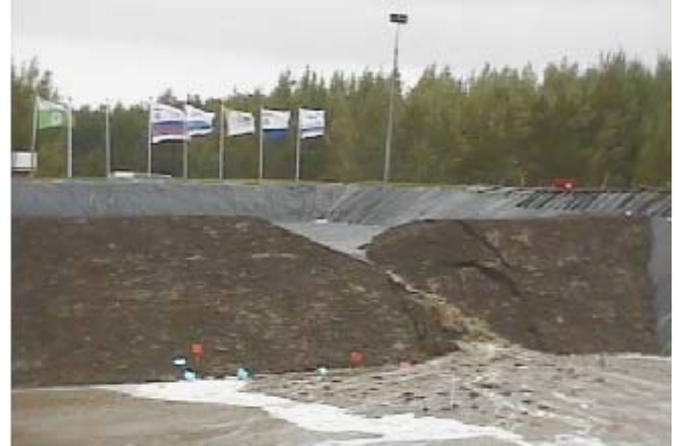
Figure 13: Collapse of the IJkdijk-Piping experimental dyke after the internal erosion process is completed (from Sticing IJkdijk).
