Airport runway repair employing Polyfelt 14 paving fabrics

Project	: Zeltweg Airbase, Austria
Consultant	: Dipl. Ing. Vasiljevic, Fa. Prüfbau
Contractor	: STRABAG Austria
Sub-contractor	: Teerag-ASDAG, Zwettler
Design and specification	: Zivilingenieurbüro Bieler, Graz
Products Used	: TenCate Polyfelt PGM 14; 150,000 m ²
New Overlay	: From the bottom to the top: 3 layers asphalt concrete: – 60mm BTS 0/22 – 50mm BTS 0/16 – 30mm AB 11 "Anti-Skid" - Surface
Construction Date	: 1990

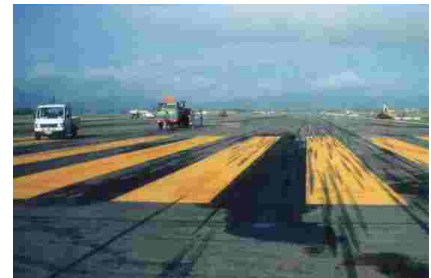
Figure 1: Runway prior to maintenance works

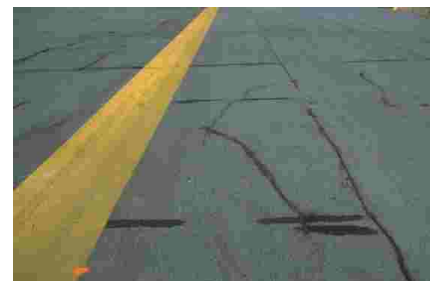
Severe cracks had reflected from the concrete surface through the asphalt overlays. The total area to be repaired was 1700 x 80m = 136,000m².

Figure 2: Reflection cracks from the old concrete surface

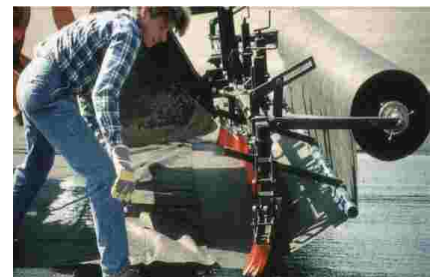
Figure 3: The Polyfelt PGM paving fabric was installed using a laying device fixed to the bucket of a front end loader. Brushes behind the fabric ensure smooth laying.

After application of 1.2 kg/m² polymer modified bitumen, the paving fabric Polyfelt PGM 14 was installed using a special laying device which was mounted on the bucket of a front loader.

For logistic reasons, the complete area was covered with Polyfelt PGM prior to the installation of the asphalt overlay. Approx. 20.000 m² per day were installed by the installation crew, consisting of the bitumen spraying device, Polyfelt PGM installation device and two workers.

The overlaps of the Polyfelt PGM panels of 20 cm were glued by an additional 0.9 kg/m² of tack coat in order to guarantee consistent adhesive bonding at the joints.

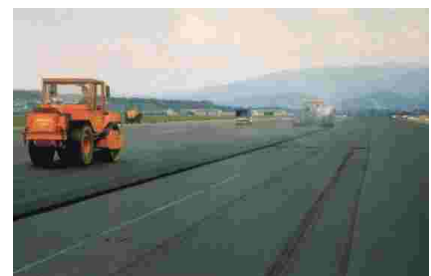
Figure 4: Installation and compacting of the asphalt concrete overlay

The installation of the asphalt overlay was done in three layers, using three finishers working in echelons. The total quantity of asphalt concrete amounted to 40.000 tons.
