# San Diego Bay gets an underwater facelift

## Geotextile cap is a key to this novel seafloor remediation project

**Project title:** Sediment remediation and aquatic enhancement at the former Campbell Shipyard site

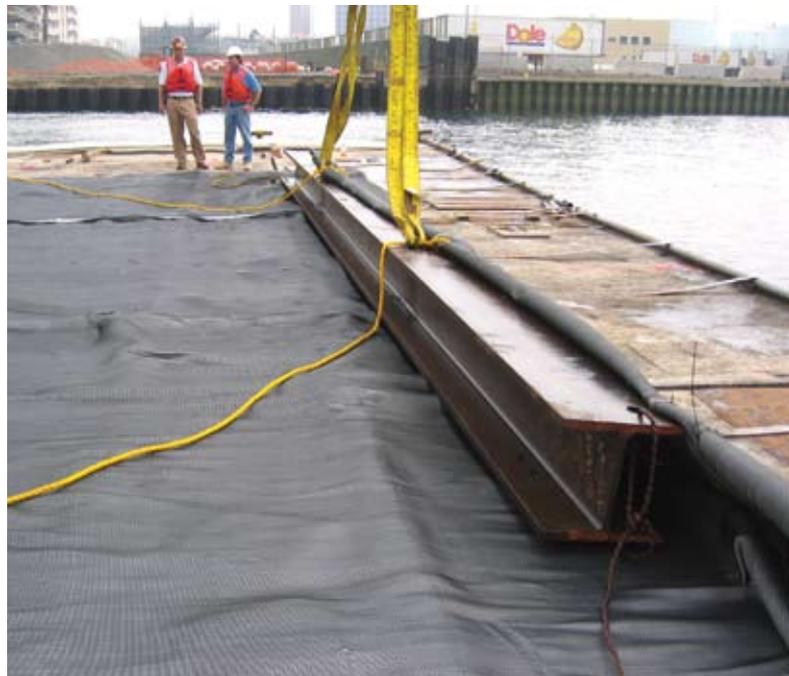
**Prep and staging** | Prep and staging using an I-beam: To establish the start of a fabric run on the seafloor, the geotextile was attached to an I-beam. The positioning of the fabric was established with a global positioning system, monitored by the field superintendent and the crane operator.

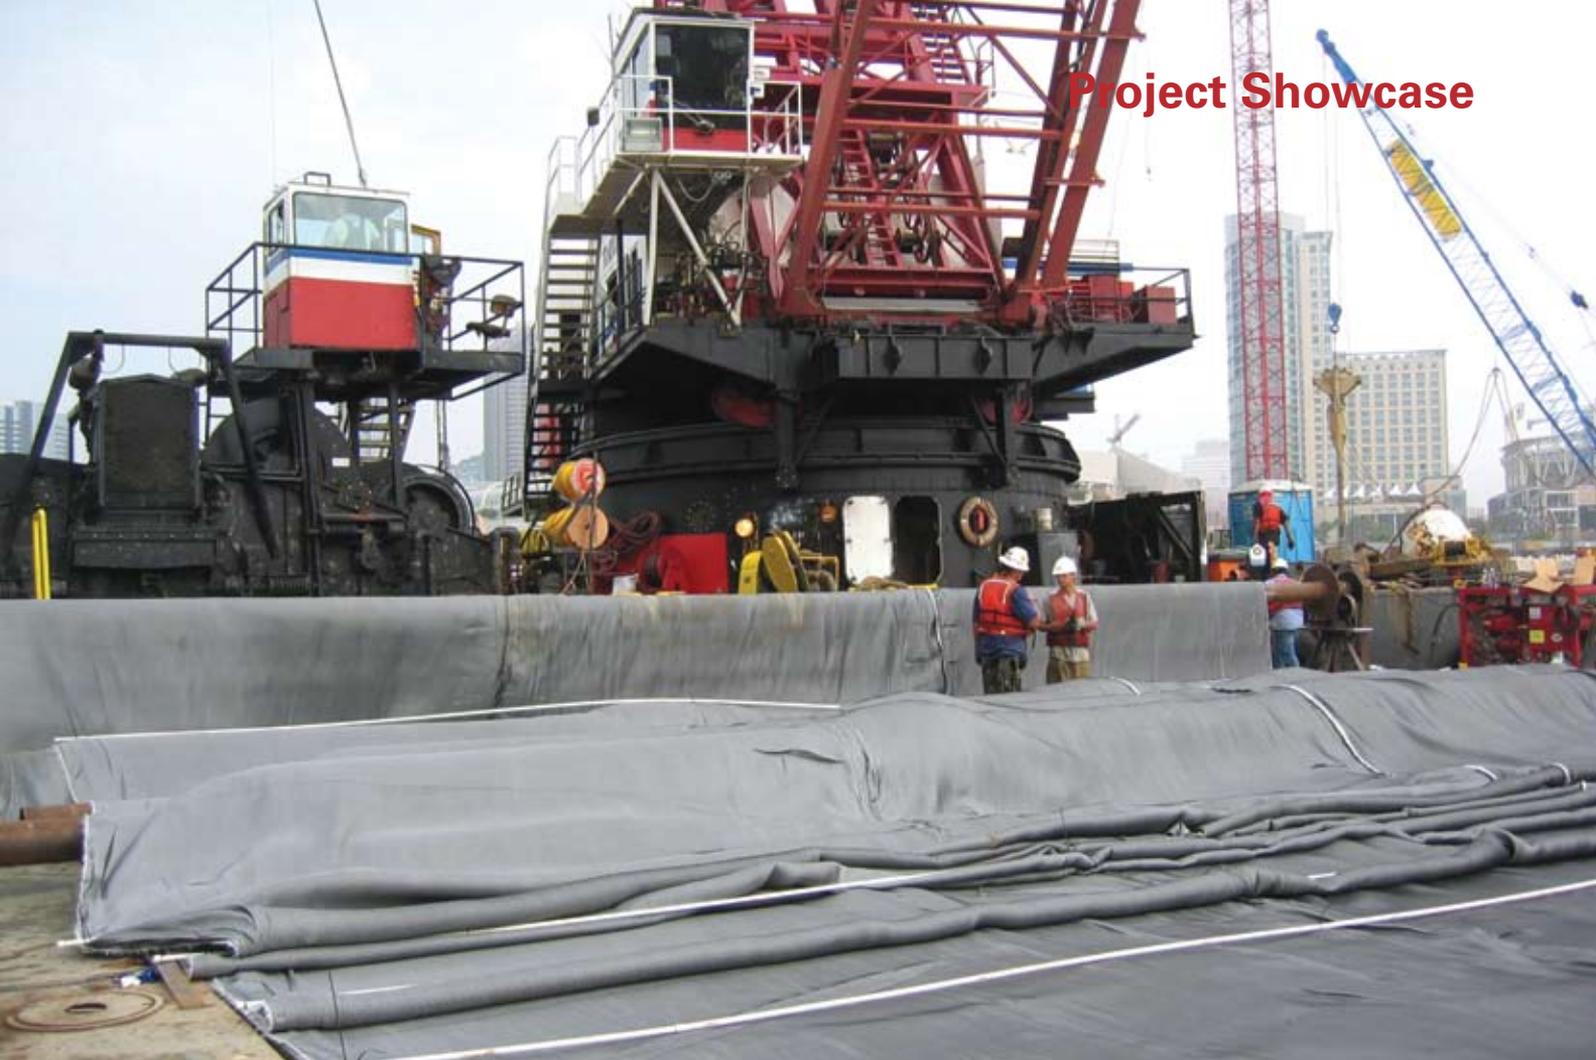
**Rebar and prep/staging** | The rebar was encased in PVC pipe capped at both ends. It was then attached approximately every 10 yards along the length of the fabric to help in deploying fabric into the water and to aid in positioning the fabric on the seafloor.

To aid in the deployment and accurate placement of the fabric on the seafloor, the contractor attached #4 rebar encased in PVC pipe with capped ends. The rebar was attached perpendicular to the fabric about every 10 yards prior to being rolled off a floating sectional barge into the water.

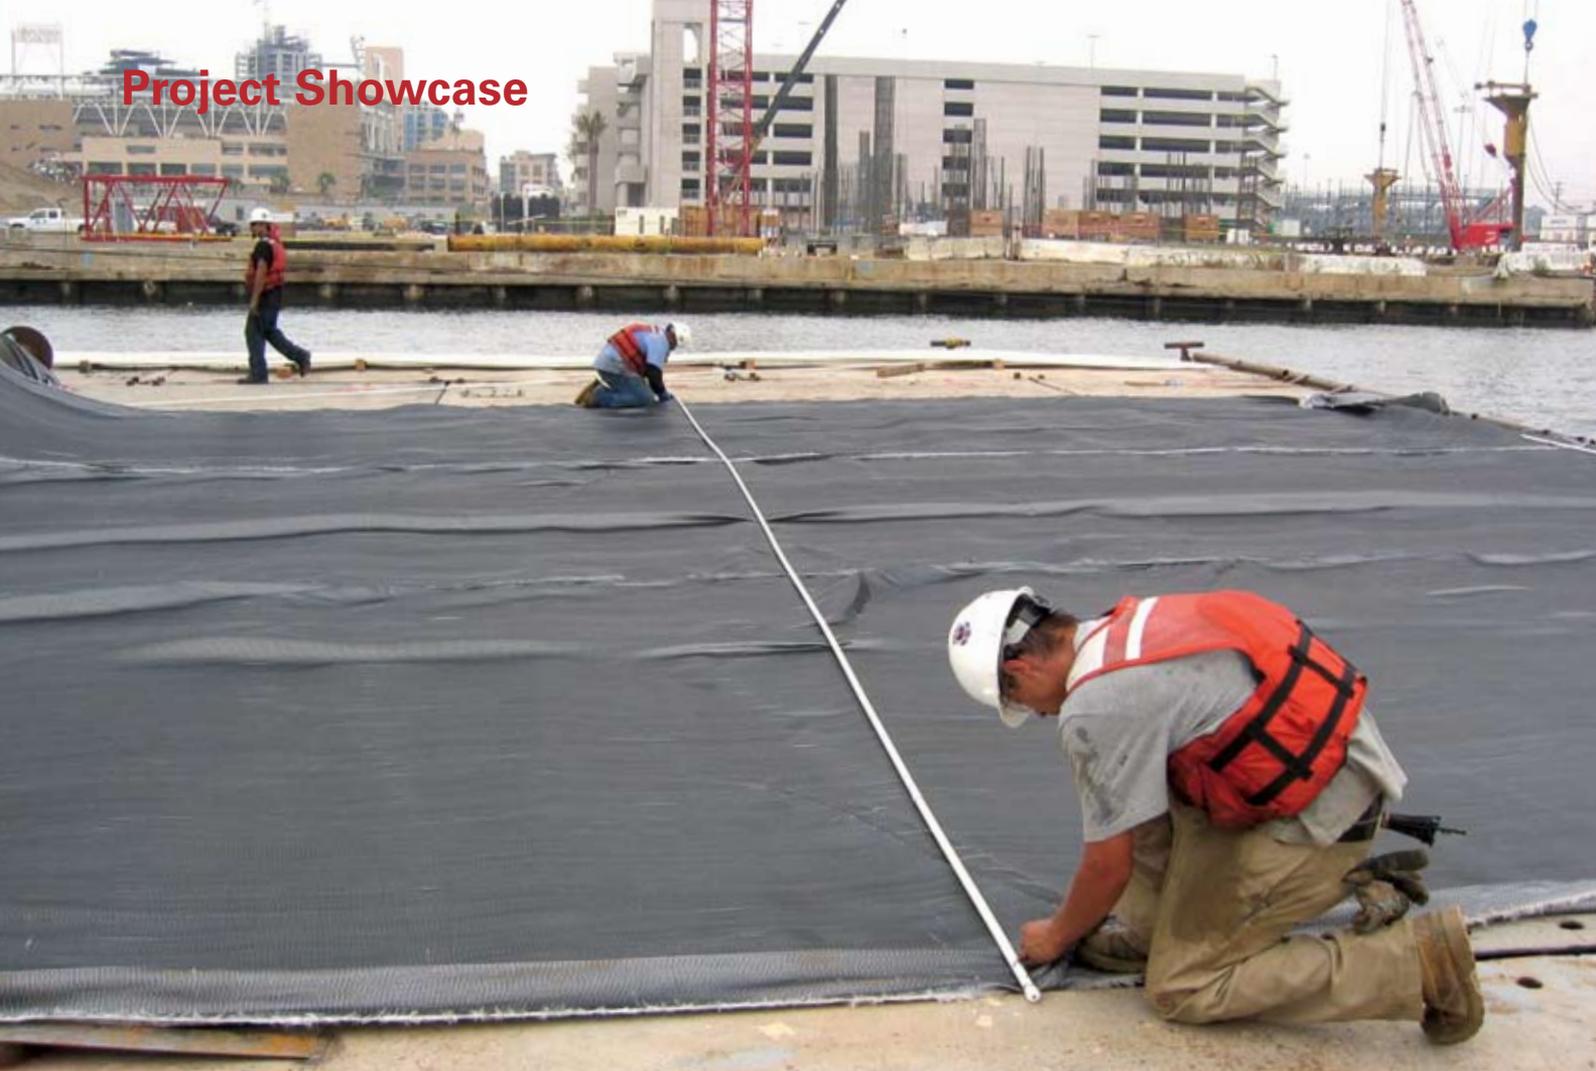
**Rebar process** | Workers attached rebar across the full width of the 45-ft.-wide, 900-ft.-long roll of geotextile fabric.

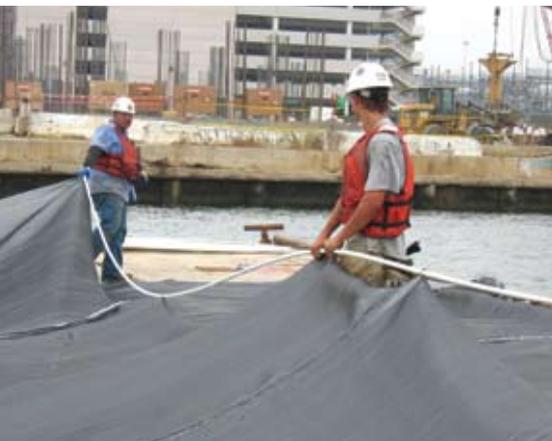
**Rebar process** | The rebar was attached onto the fabric using zipties approximately every 10 yards along the width of the entire length of the 900-ft.-long geotextile roll.

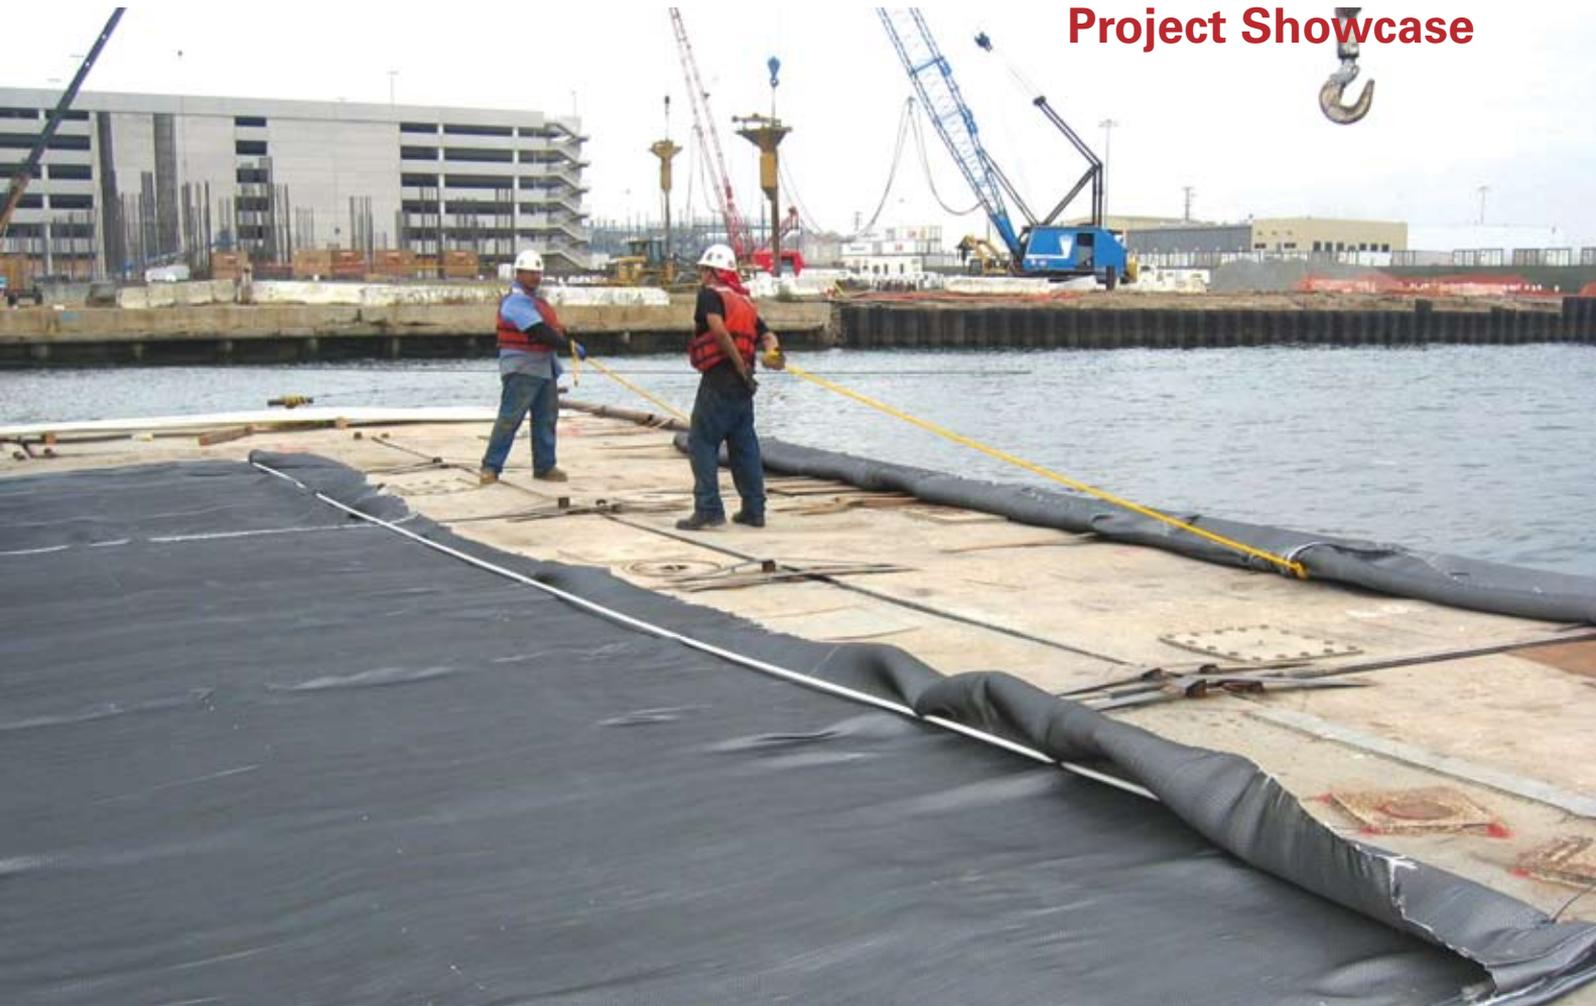
**Deployment** | The rolls of fabric were unfurled and floated into the bay from the deck of an 80-ft. x 60-ft. sectional barge.

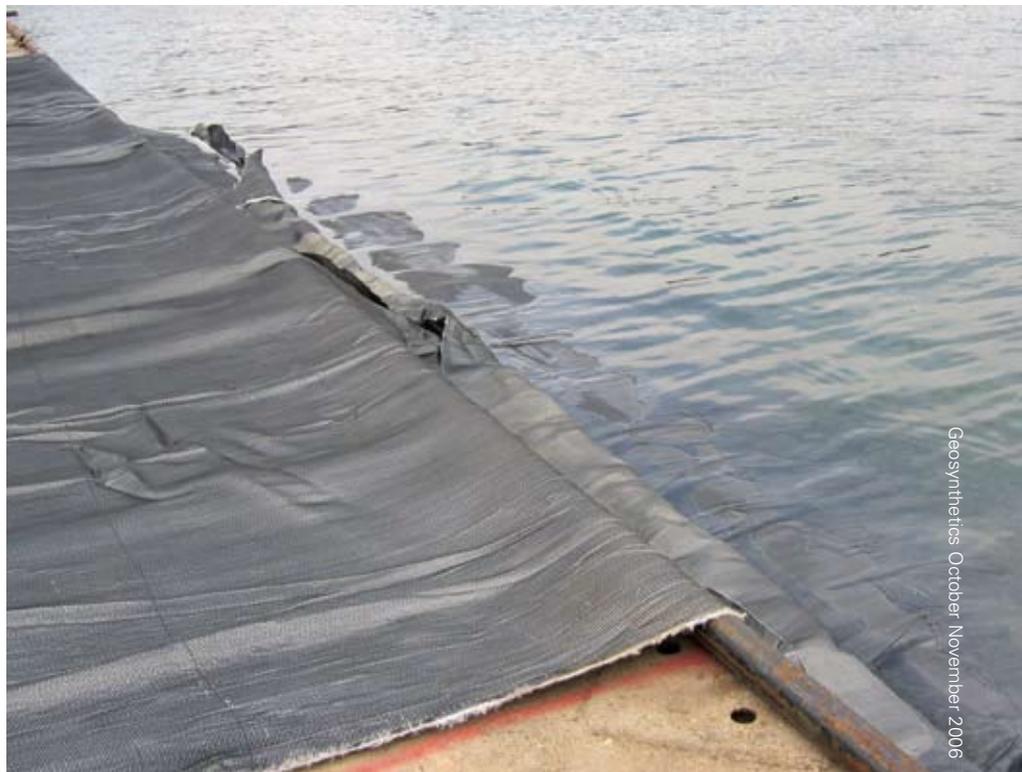
| The geotextile fabric floats into the water.

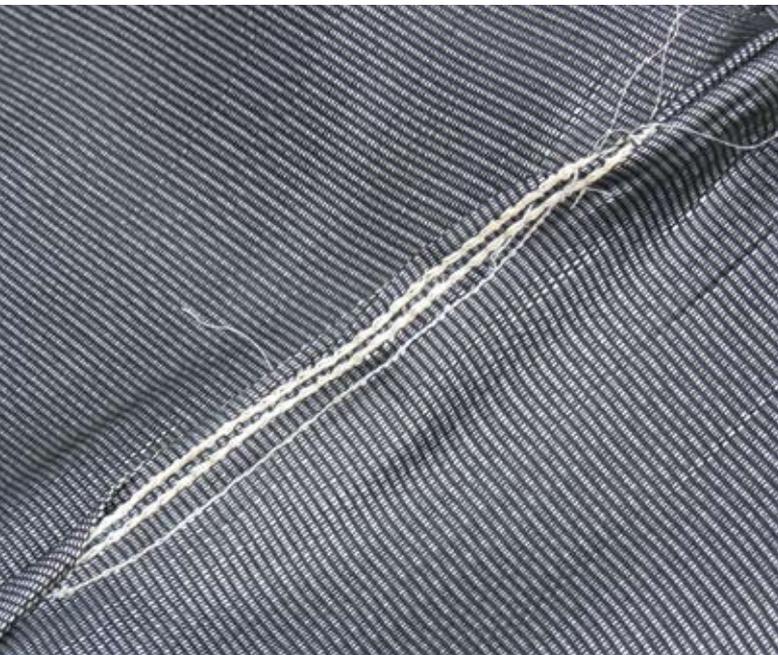
**Closeup of the textile** | This is the seam of the fabric—3 15-ft.-wide fabric panels were sewn together to get the desired width of 45 ft. It was then folded and rolled prior to shipping to California from Georgia. The fabric rolls had to be unrolled and unfolded, then attached to the 50-ft.-long spool on the floating deployment platform.

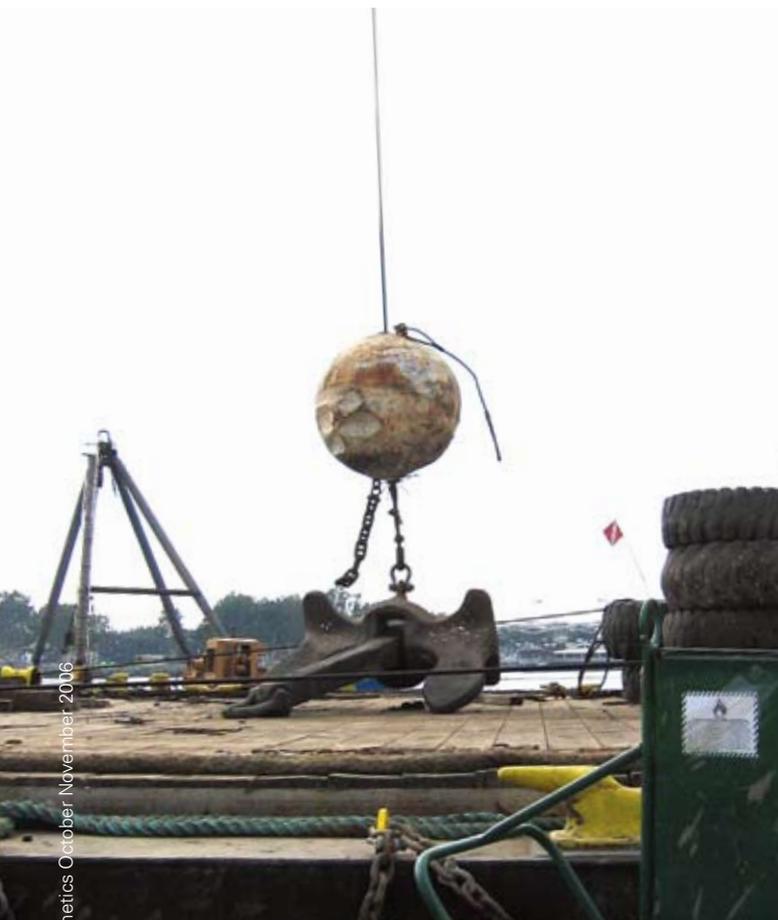
**Crane with ball/anchor** | When the derrick barge is moved, these 15-ft.-high anchors also have to be repositioned.
