Case Study

application | Landslide Repair
location | Jordan, MN
product | Miragrid® 5XT Geogrid

job owner | Dr. Lyle and Esther Kraugh
engineer | Gale-Tec Engineering, Inc.
installer | Rachel Contracting

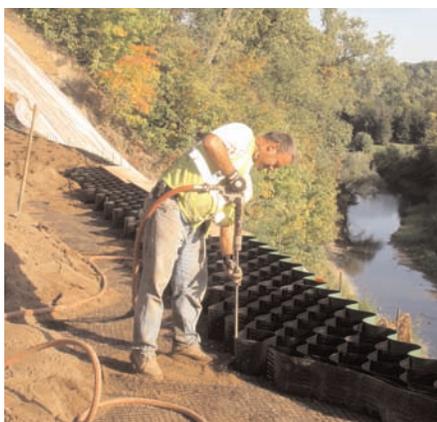
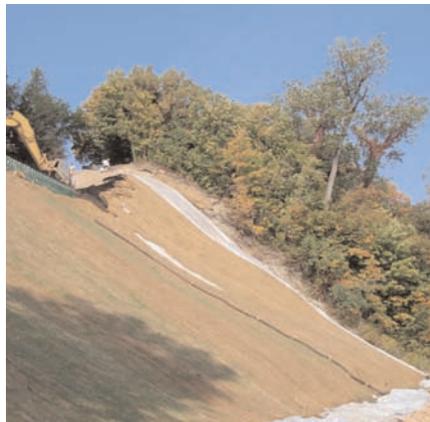
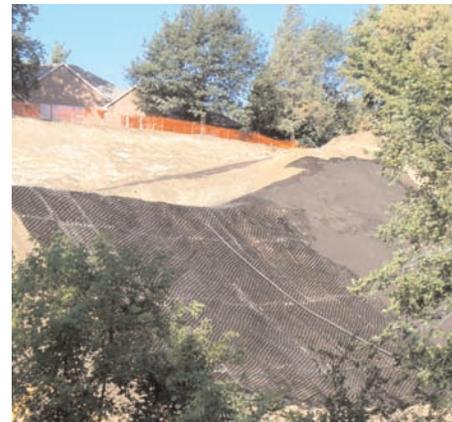
The construction started with subcutting the upper slope of existing clay soil. The top of the subcut was utilized as an access point for the top of the lower slope. Then the 4" cellular confinement was installed on the lower slope, backfilled, seeded and covered. At the same time a rip rap layer was installed along the creek slope to minimize future scouring of the toe of the slope. Upon completion of the lower slope, the upper slope was constructed from the bottom layer up. A Cat 330 excavator, Cat 277 skid steer and labor with vibratory plate compactors were used to build up the lower slope. Upon completion of the lower slope, final restoration of the backyard including installation of a spit rail cedar fence at the top of the slope was completed. The repair included a blanket drain at the base of the RSS and extended up the backslope as shown in Figure 1. The purpose of the blanket drain was to help alleviate seepage pressures within the slope soils. The blanket drain consisted of Mn/DOT 3149.2H Coarse Filter Aggregate. Mirafi® 180N geotextile was placed above and below the blanket drain.

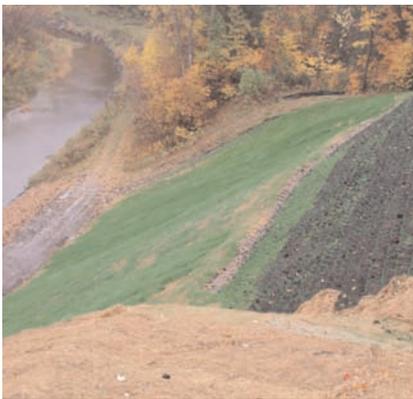
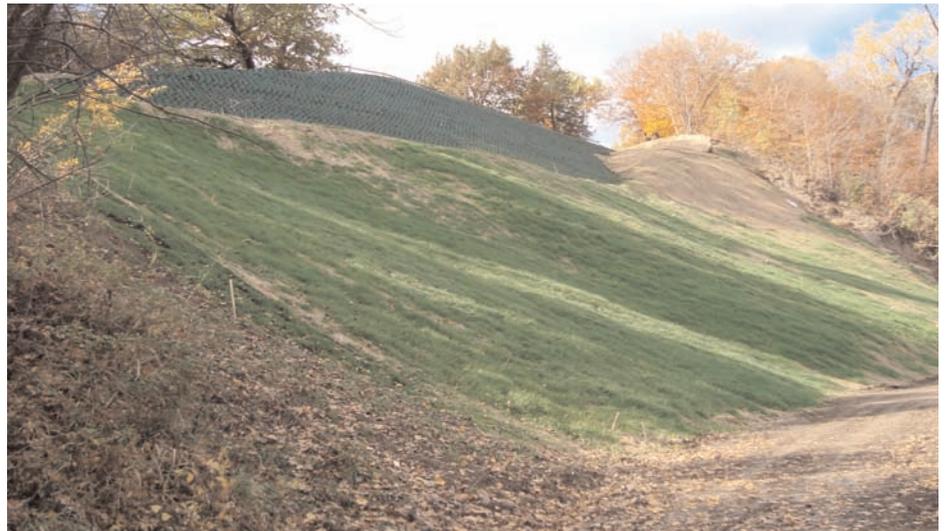
The slope has been permanently restored and is performing as expected without any further erosion to date.
