# Polyfelt® PEC Slope Failure Repair

Jalan Gunung Raya -Langkawi, Malaysia

<b>Project</b>	: Langkawi Kedah Darul Aman, Malaysia
<b>Application</b>	: Reinforcement of a 35m-high slope using sandy soil backfill
<b>Owner</b>	: Public Works Department (PWD), Malaysia
<b>Products Used</b>	: TenCate Polyfelt® PEC 150

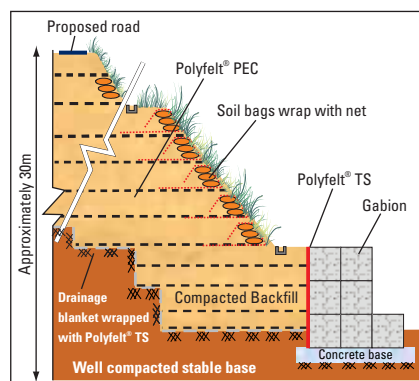
Figure 1: Proposed reinforced wall.

net around bags filled with fine-grained soil. This method of construction facilitates practical construction of a curved slope. TenCate Polyfelt® PEC composite geotextile was laid behind the gabion and soil bags to strengthen the structure (Figure 1). A layer of TenCate Polyfelt® TS geotextile filter was placed behind the gabions to prevent soil piping through the voids in the gabions.

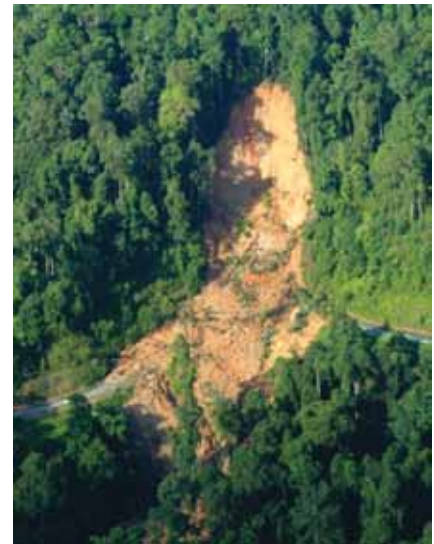
Figure 2: Aerial view of the slope failure.

Continuous rainfall resulted in a major landslide on the Federal Route that leads to the highest mountain (881m) in Langkawi which houses a museum, a park and a satellite control centre. The landslide significantly disrupted traffic and posed a danger to road users.

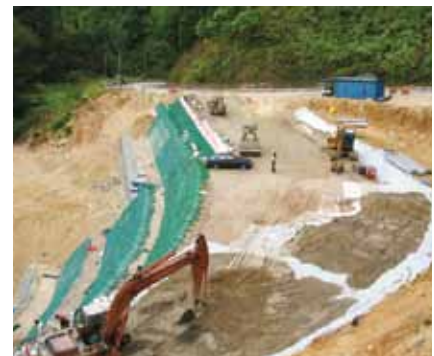
Figure 3: Reinforcing slope with Polyfelt® PEC.

The primary reinforced direction of TenCate Polyfelt® PEC composite geotextile was installed perpendicular to the slope's surface. Pretensioning of the composite geotextile was done by packing it in position with the aid of wooden pegs. Compaction of backfill material was done using a 10 ton compactor to achieve a minimum of 90% proctor compaction. Hydro seeding was carried out after the slope was completed for a vegetated surface.

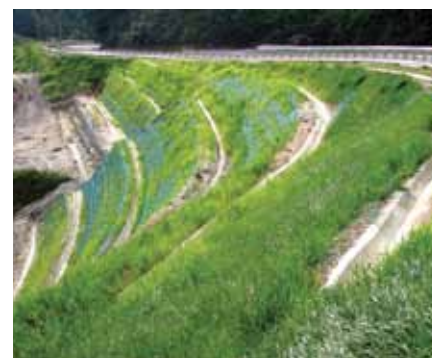
Figure 4: Vegetated slope after completion.
