## City of Williams stretches budget with double chip over fabric

Mary Stroup-Gardiner, CP2 Center, and Skip Brown, PPTG Co-Chair

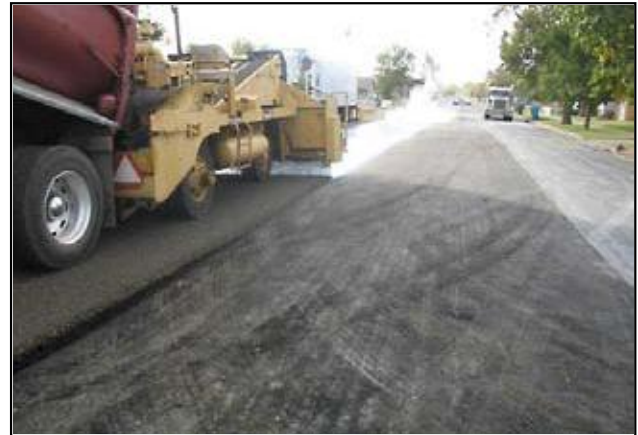
Figure 3. Sanded fabric (right) and construction of second chip seal.

As the day warmed up, the tack coat began to saturate the fabric, important for good adhesion (Figure 3). The tacky surface was sanded by mid-day to prevent local traffic from tracking the binder or pulling up the fabric. Limited local traffic helps work the fabric into the underlying cracks. The sand then works into the depressions over the cracks.

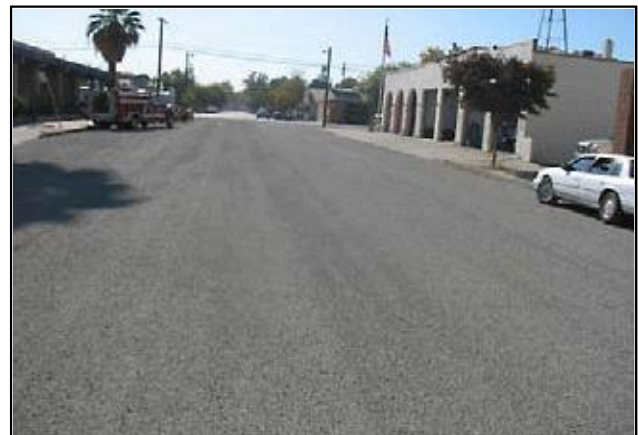
Figure 4. Finished surface.

state specification for the chips. The emulsion used was PMCRS-2H, applied at 0.32 g/sy for the first application and 0.38g/sy for the second. Chips were applied at 22 lb/sy for the first application and 25 lb/sy for the second. Sweeping the final lift began after 7 days of use by local city traffic. The overall result is a smooth, finished surface after the double chip seal is placed. (Figure 4).

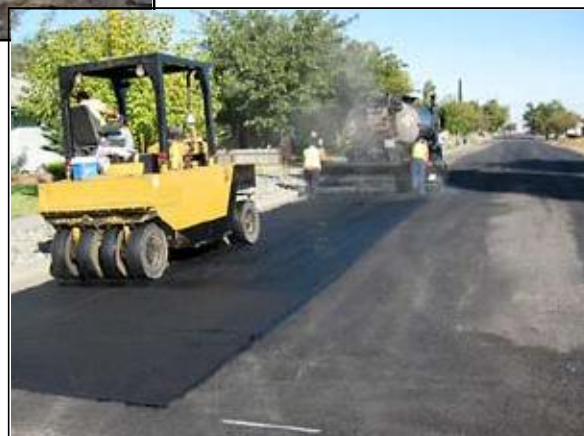
Figure 2. Crew placing fabric over tack coat followed by pneumatic tire roller to seat the fabric.

properly place the fabric by keeping it flat, worked into the tack coat and trimming the edges as the fabric is placed (Figure 2). The fabric is then imme-

diately rolled using pneumatic rollers to embed it completely into the binder.

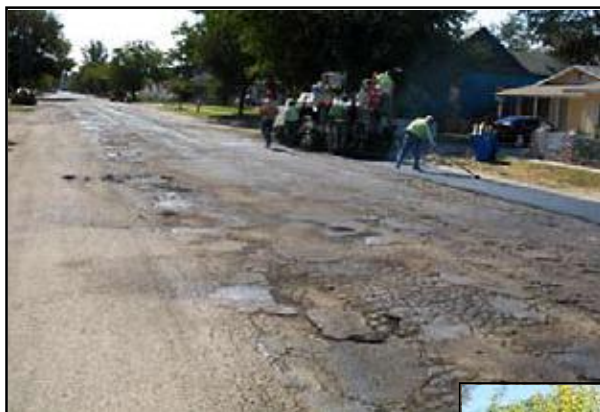
Figure 1. Limited areas of sheet patching and distressed pavement before fabric placement.

The project started by placing a thin, leveling course (856 tons) over the most severely distressed areas (Figure 1). Distressed areas with a fair ride quality were not treated. The fabric was placed into
