## Case Study

**application** Capillary Break/Wicking  
**location** Coldfoot, AK  
**product** Mirafi® H<sub>2</sub>Ri

**job owner** AKDOT  
**engineer** AKDOT  
**contractor** HC Contractors  
**date of installation** Summer 2012 - 2013

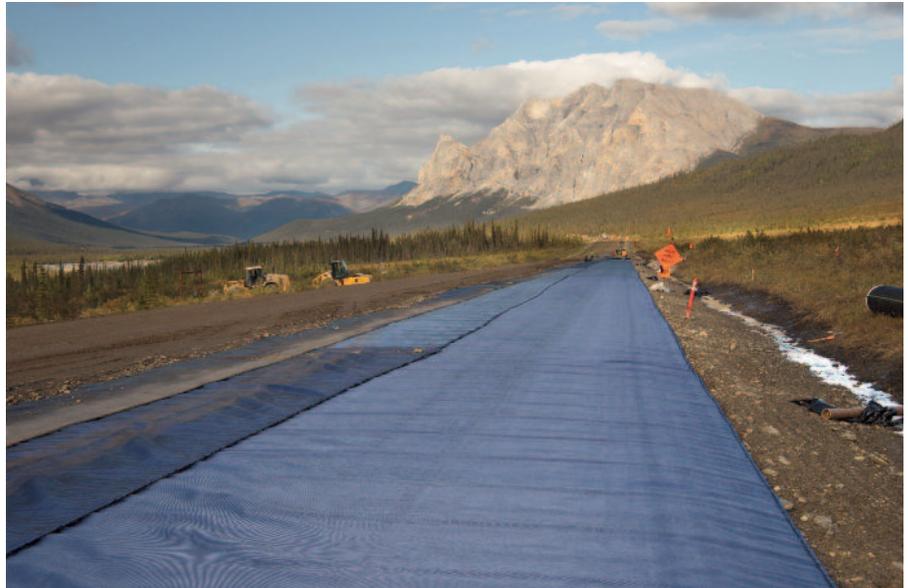
Mirafi® H<sub>2</sub>Ri geosynthetic installed with Sukukpak mountain in the background.

Installation of the 53 foot wide section was completed by installing one lane until mid-day, then moving back and installing the second half during the last half of the day in order to keep the traffic moving.

Three full roll widths and one half roll width of Mirafi® H<sub>2</sub>Ri was used with a minimum overlap of 1.5 feet. The half roll was field cut on site by using a "Sawz-All" with long blade while the geosynthetic was still on the roll.

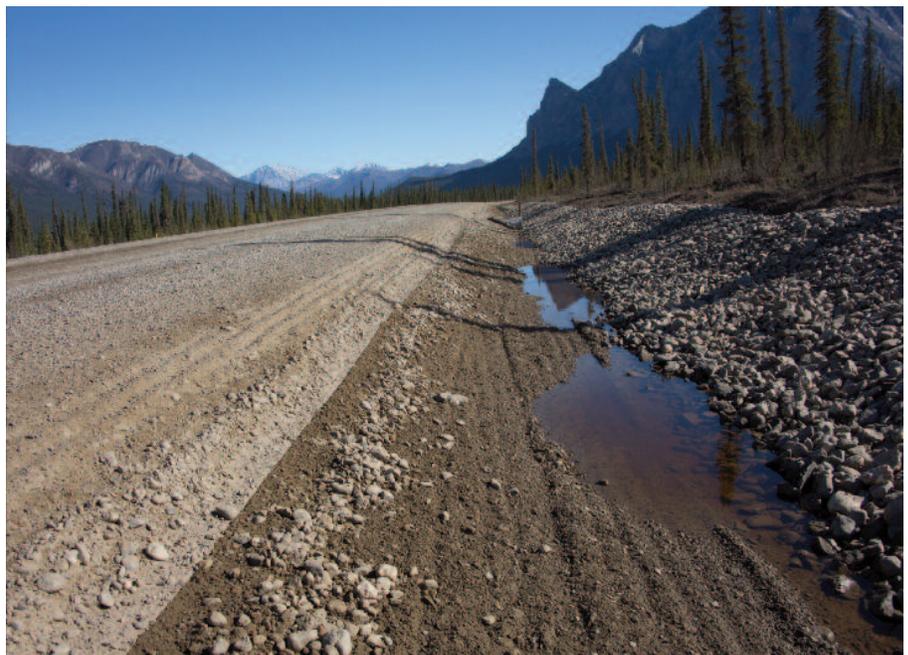
Daylighted Mirafi® H<sub>2</sub>Ri seen wicking and performing as capillary break during spring thaw.

Twelve inches of aggregate over Mirafi® H<sub>2</sub>Ri was detailed out with a 6" daylight section on both sides of the embankment. It was determined with research that water will wick in the direction of decreasing pressure so naturally, it will find its way to barometric pressure and evaporate. Mirafi® H<sub>2</sub>Ri geosynthetic is also expected to perform as a capillary break as water naturally rises via capillary action in the subgrade.

During the first winter season and spring break-up, water was seen both wicking and working as a capillary break. This project will be closely monitored over the next few years to observe the performance of Mirafi® H<sub>2</sub>Ri.
