**State of Michigan  
Department of Environmental Quality  
CPC Site, Monroe, Michigan**

Lagoon and Ditch Sediment Dewatering Utilizing Geotubes®  
Preliminary Pilot Demonstration - Summary Report, May 30, 2003

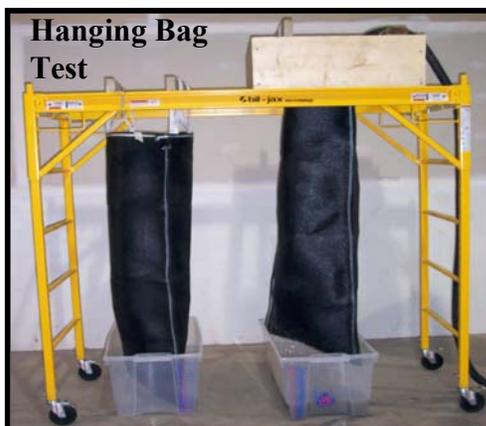
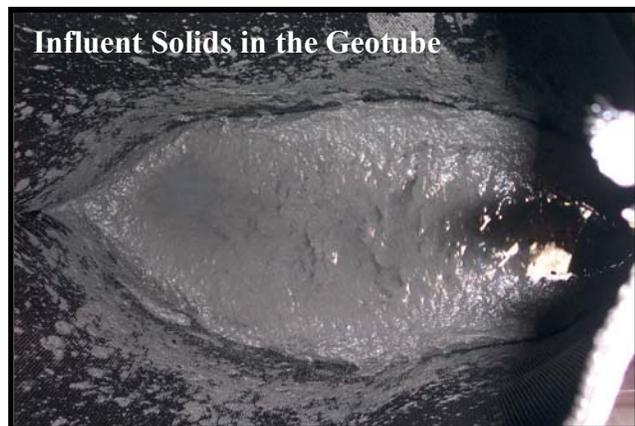
Figure 1 – Hanging Bag Pilot Test

The test apparatus included a metal framework made of common painters scaffolding and wood support blocks, a hanging Geotube® test bag, (thus termed the “Hanging Bag Test”), a common gas powered trash pump with flexible discharge hose, 50 gallon plastic drum for feed sludge, a hand held electric drill equipped with a 24-inch paint mixer attachment, 30 gallon plastic filtrate catch containers and a suitable polymer dewatering aid.

Four test bags were filled on Tuesday, April 21, 2003; and the test continued 10 days through Tuesday, May 2, 2003. The hanging bag test was set up in a manner shown below:

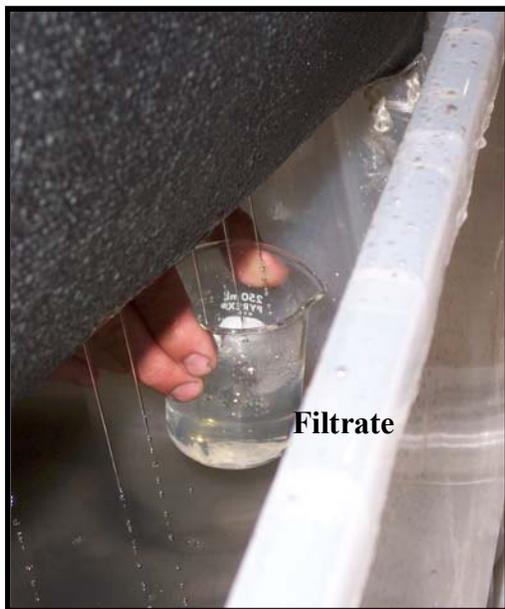
Each test utilized approximately thirty-five (35) gallons of sludge mixed with a cationic polymer for approximately five-ten minutes until a discernable solids floc formed. Polymer doses ranged from 50 ppm to 100 ppm. Agitation was provided via the electric drill and mixer attachment and floc formation was confirmed visually. The mixture was then pumped into the top opening of the hanging bag via utilizing the trash pump. Pumping duration varied from brief, about 1-2 minutes to transfer the mixture into the hanging bag once the pumping started. Note: Samples from the various locations varied in consistency and character. Lagoon Number 2 had the lowest “viscosity” and pumped easily. The East Ditch was thicker and did not pump as well. The sample from the West Ditch was very thick and pumped with difficulty as it was difficult to get the trash pump to establish a “prime”. All samples had varying amounts of sand, small stones, sticks, grass, and

reeds. The West Ditch sample had the most debris and sand of the three samples, which included a two-inch diameter rock that clogged the trash pump.
