## Case Study

**application** | **Landslide Repair**  
**location** | **Trump National Golf Course, CA**  
**product** | **Mirafi® PET600, PET300, & PET200**

**job owner** | **Donald Trump**  
**contractor** | **Sukut Construction**

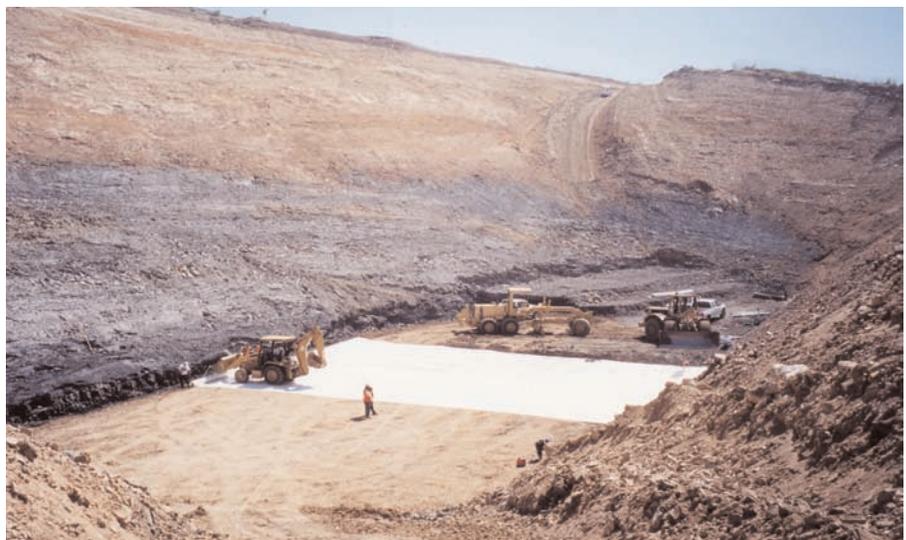
Mirafi® PET high strength geotextiles met the design requirements of 600 kN/m (40,000 lb/ft) tensile strength and high soil interaction coefficients.

The design required extremely high strength fabrics, over 600 kN/m (40,000 lbs/ft) tensile strength, combined with high soil interaction coefficients. Layers of geosynthetic reinforcement were to be placed at approximately 1.5 m (5 ft) vertical intervals with embedment lengths as much as 29 m (95 ft) in length. Mirafi® PET600, PET300, PET200 and HS4200 were used as the primary reinforcement to create a massive 30.5 m (100 ft) high fabric wrapped MSE wall/buttress. The face of the wall was designed with 46 cm (18 in) high welded wire

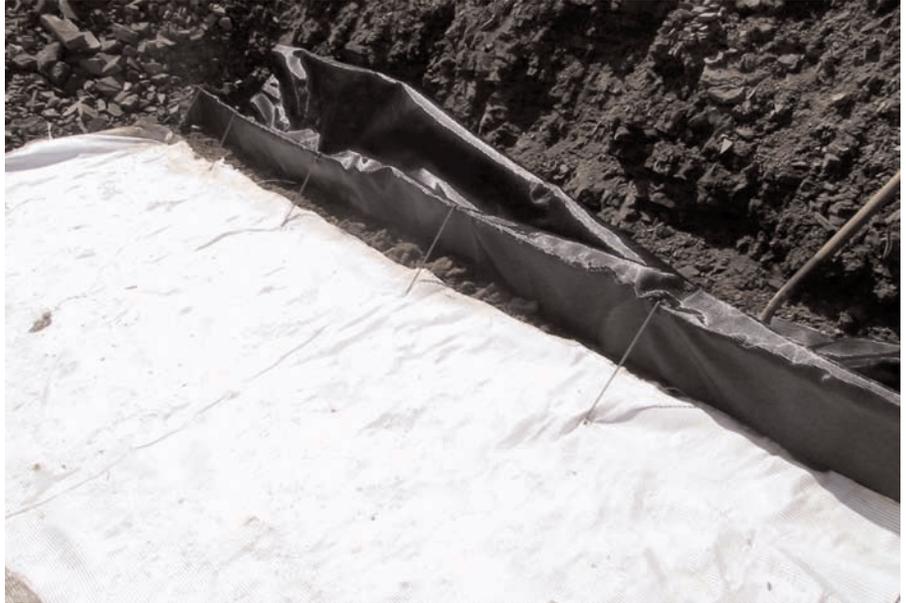
Mirafi® FW404 was placed inside the welded wire basket forms to contain soil at the face. The Mirafi® HS geotextile was installed next to the basket face.

forms, with a nearly vertical batter of 4.6 degrees. As secondary reinforcement, Mirafi® FW404 was used to line the interior of the welded forms to contain soil at the face. The face of this massive MSE wall was to be butted up against another reinforced triangular backfill (also using Geolon® fabrics). This second reinforced fill mass was butted up against existing slide material/native soils of the seaward portion of the landslide, which was left in place to maintain the natural environment, hide the face of the wall, and protect the MSE structures from the Pacific Ocean. This composite of soil and high strength fabric serves as a giant stable soil block that will stop any future movement and protect the rest of the golf course from falling into the ocean.

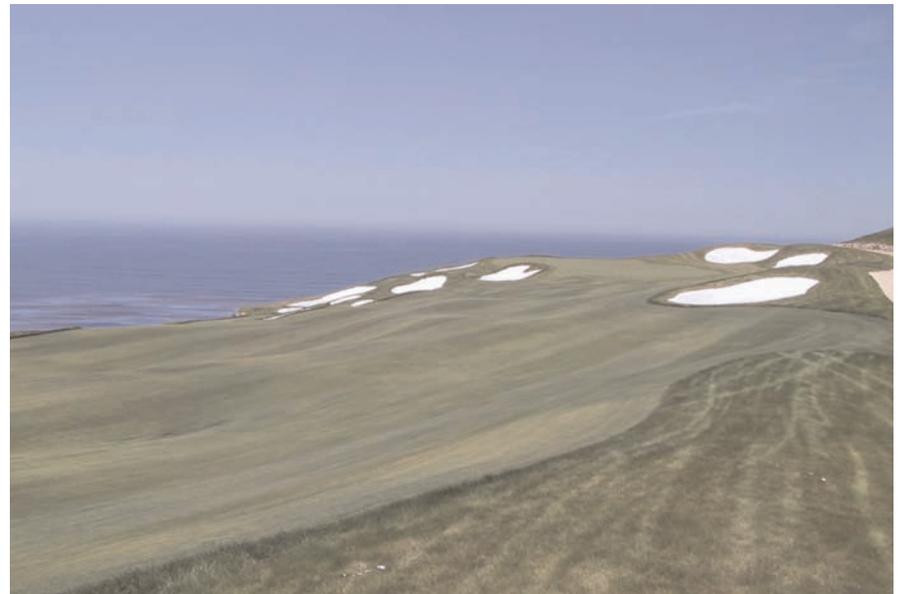
The 18th hole of the Trump National Golf Course is considered one of the safest coastal locations due to the high strength geosynthetics stabilizing the earth.
