Application Story

PROJECT | HOG FARM LAGOON CLEANOUT
 Product | Geotube® Dewatering Technology
 Application | Agricultural

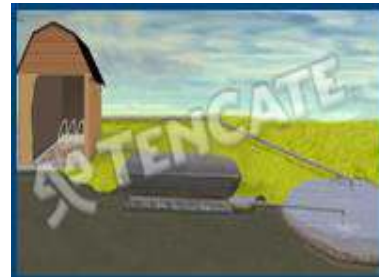
Geotube® dewatering technology was used as a simple, effective way of managing the lagoon cleanout. The waste was pumped from the lagoon to a Geotube® unit [photo 3].

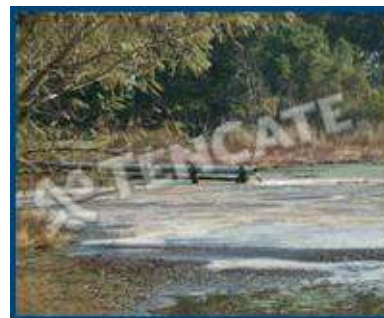
Solids were at 4% when pumped from the lagoon. Within the Geotube® container, the solids dewatered to over 25%. The container retained 93% of solids, plus 78% of nitrogen and 65% of phosphorous. The unfiltered discharge was clean enough to enter the lagoon [photo 4].
