Case Study

application | **Surficial Slope Reinforcement and Drainage**

location | **Livermore, CA**

product | **Mirafi® 2XT, 140N, G200N**

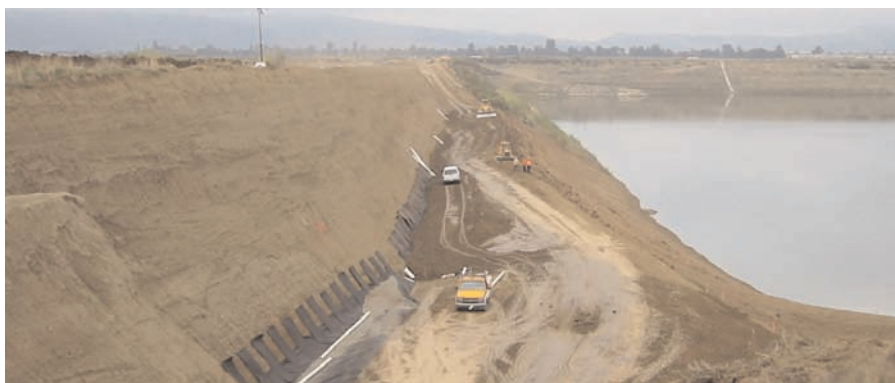
Mirafi® G200N, used as chimney drain, ties into Mirafi® 140NC wrapped subdrain system.

The engineer used Mirafi140N as a permeable separator geotextile that was wrapped around drain rock like a "burrito" at the foot of the slope. The Mirafi 140N allows water to freely pass through, while keeping the fine grained soils out of the drain rock. The Mirafi G200N was then tied into the Mirafi 140N burrito at the foot of the slope. Mirafi Miragrid 2XT geogrid was specified for use in the outer four feet of the slope face to maintain surficial stability of the slope face. The Mirafi Miragrid 2XT was designed to be placed every two vertical feet for the entire height of the slope. The slope was specified with a temporary erosion blanket to give temporary erosion protection for the hydro seeded slope.

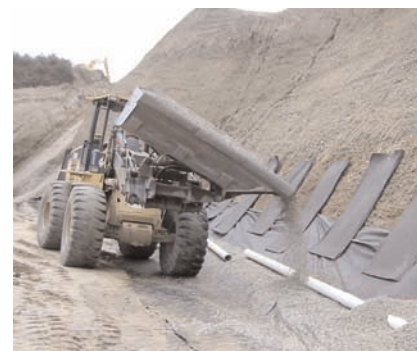
Above: Drain rock being dumped on pipe and Mirafi® 140NC.

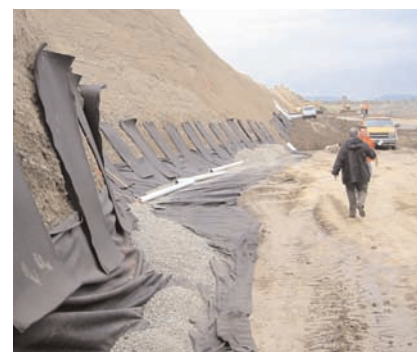
Below: Mirafi® G200N terminating at subdrain system.
