Case Study

application Subgrade Reinforcement
location Sausalito Yacht Harbor, Sausalito, CA
product Mirafi® RS380i

job owner City of Sausalito
engineer Kyrk Reid
contractor Reyes Construction, Inc
date of installation December 2011

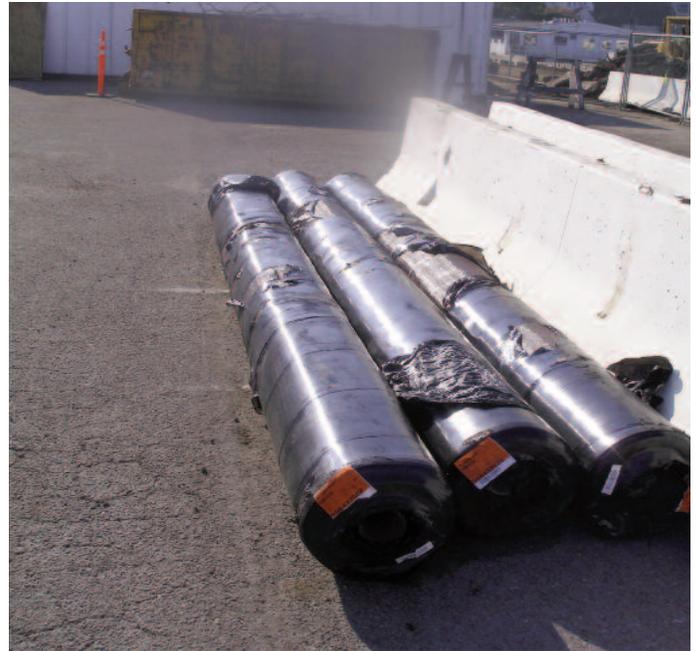
The unique orange colored Mirafi® RS380i arrived at the site with plastic protective covers.

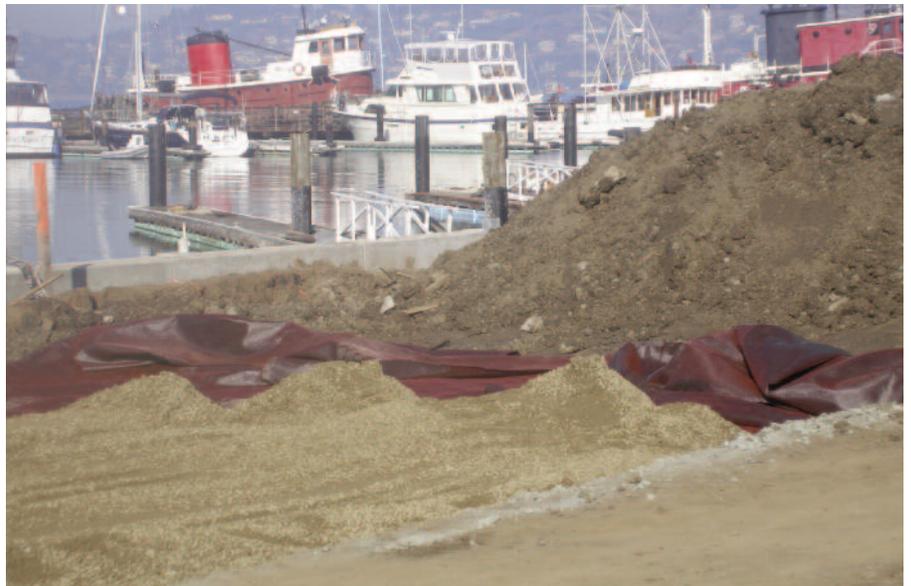
Mirafi® RS380i was deployed manually over the rubble and debris fill.

Mirafi® RS380i was deployed by hand over the poor subgrade easily by two laborers at the site. Due to the superior performance of the geotextile, the contractor was able to reduce the aggregate layer from 12 inches to 10 inches while still easily achieving the desired 95% compaction requirement. Finally, 4 inches of asphalt were placed over the aggregate to complete the installation.

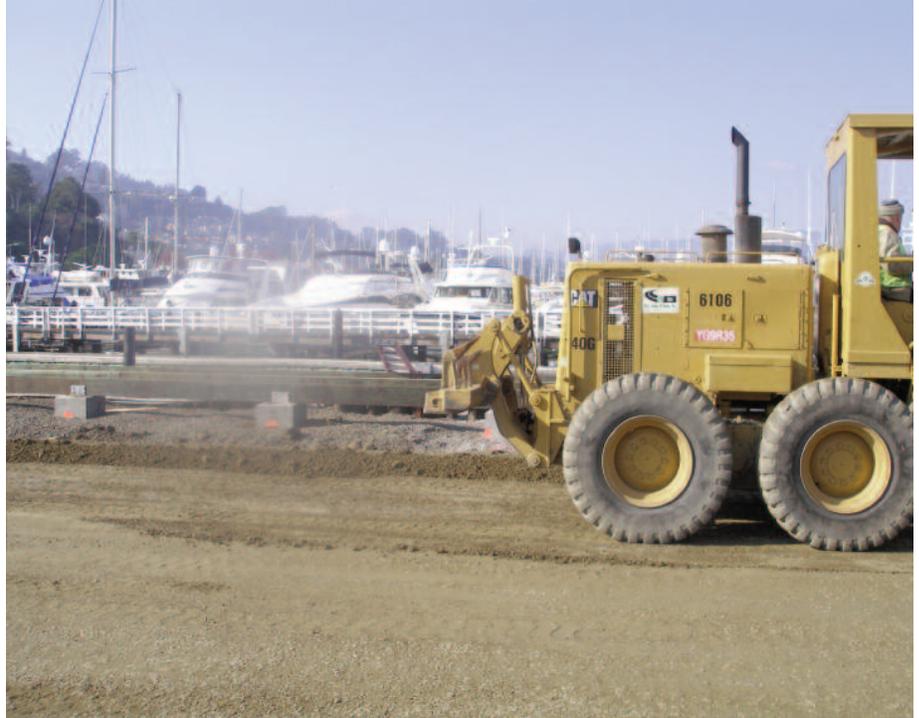
Using Mirafi® RS380i in the parking lot allowed the design to reduce the aggregate from 12 inches to 10 inches.

The contractor was able to achieve a stable reinforced subgrade by using Mirafi® RS380i. They were able to reach the desired compaction needed and eliminate 2" of aggregate for a net cost savings for the overall project. Mirafi® RS380i not only provided a stabilized platform for the parking lot, it also provides a permanent separator to keep the fine grained soils of the underlying subgrade from infiltrating into the aggregate section (bearing capacity will decrease if fines are allowed to infiltrate the aggregate). It is estimated that the parking lot will last a minimum of 50% longer than anticipated by using Mirafi® RS380i to reinforce the subgrade.

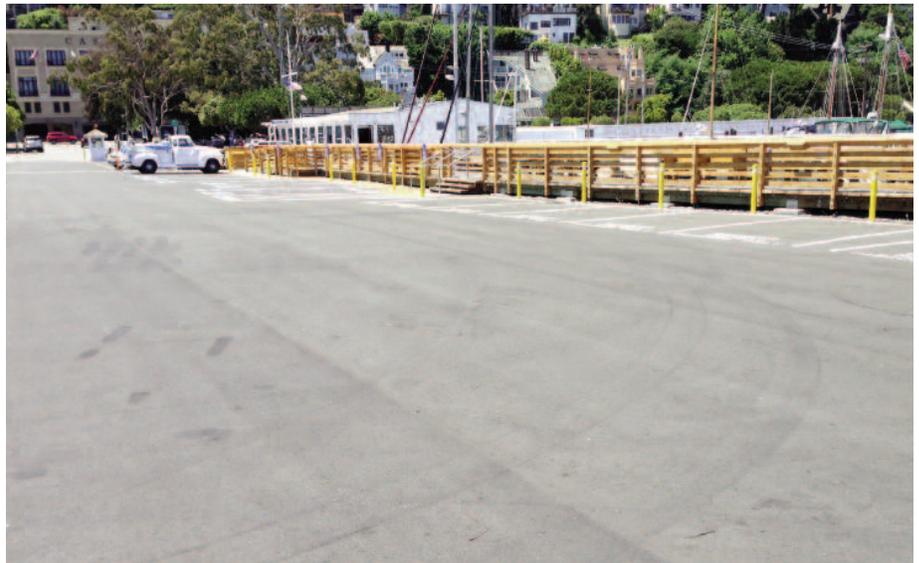
4 inches of asphalt were placed over the compacted aggregate to complete the parking lot rehabilitation.
