Canals and rivers: Melaka River remediation, Melaka, Malaysia

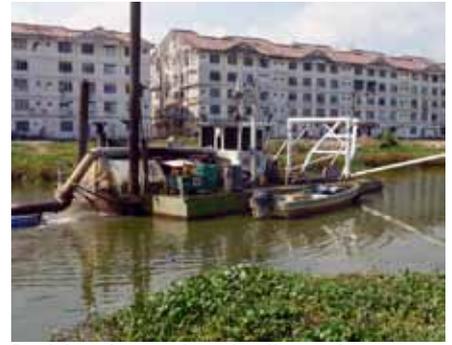
Dredging of contaminated sediments from Melaka River

The decision was made to dredge the Melaka River along a 13.5 km length through the built-up area of the city in order to remove the contaminated sediments and to reshape the geometry of the river so that it would become naturally self-flushing. This entailed

Due to the high levels of trash encountered in the river sediments dredging had to be carried out in a careful manner. To prevent blockage of the pipeline to the Geotube® dewatering facilities a trash separation unit was installed to filter out the trash from the contaminated sediment slurry following dredging.

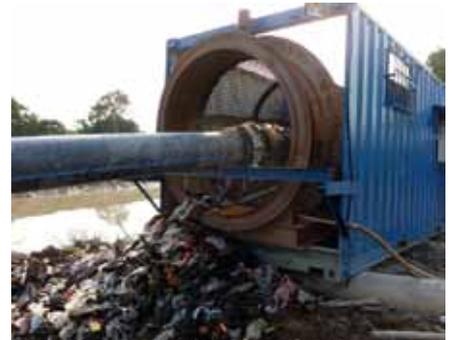
Separation of trash from contaminated sediment slurry

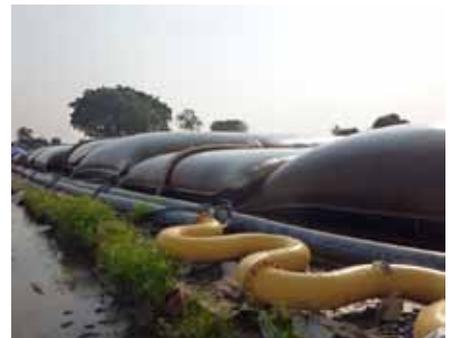
Geotube® dewatering of contaminated sediments showing slurry delivery pipes

The dredged contaminated sediment slurry was dosed with the optimum chemical dewatering accelerant prior to entry into the Geotube® dewatering containers. To efficiently fill the Geotube® containers approximately 10 filling and dewatering cycles were carried out. During dewatering, the effluent water was tested for quality and then returned directly to the Melaka River. The complete dewatering process occurred over a 2 to 3 month period.

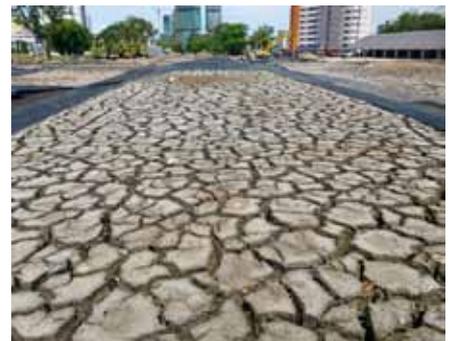
State of contaminated sediments following Geotube® dewatering

Once the dewatering process had been completed the Geotube® containers were cut open. The dewatered contaminated sediments now resembled a solid material that could be easily excavated and loaded onto transport for removal to a local landfill facility.

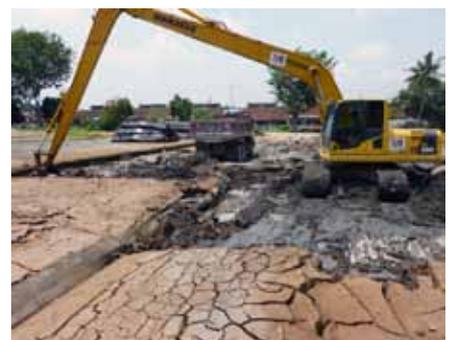
Excavation of dewatered contaminated sediments for transport to offsite landfill
